QUEEN MARY HOTEL

- o HULL STRUCTURAL ANALYSIS
- o PIPING AND BALLAST SYSTEMS
- o MAINTENANCE STUDY

RADOS INTERNATIONAL CORPORATION
POST OFFICE BOX 830
SAN PEDRO, CA 90733

DATE: SEPTEMBER 26, 1990

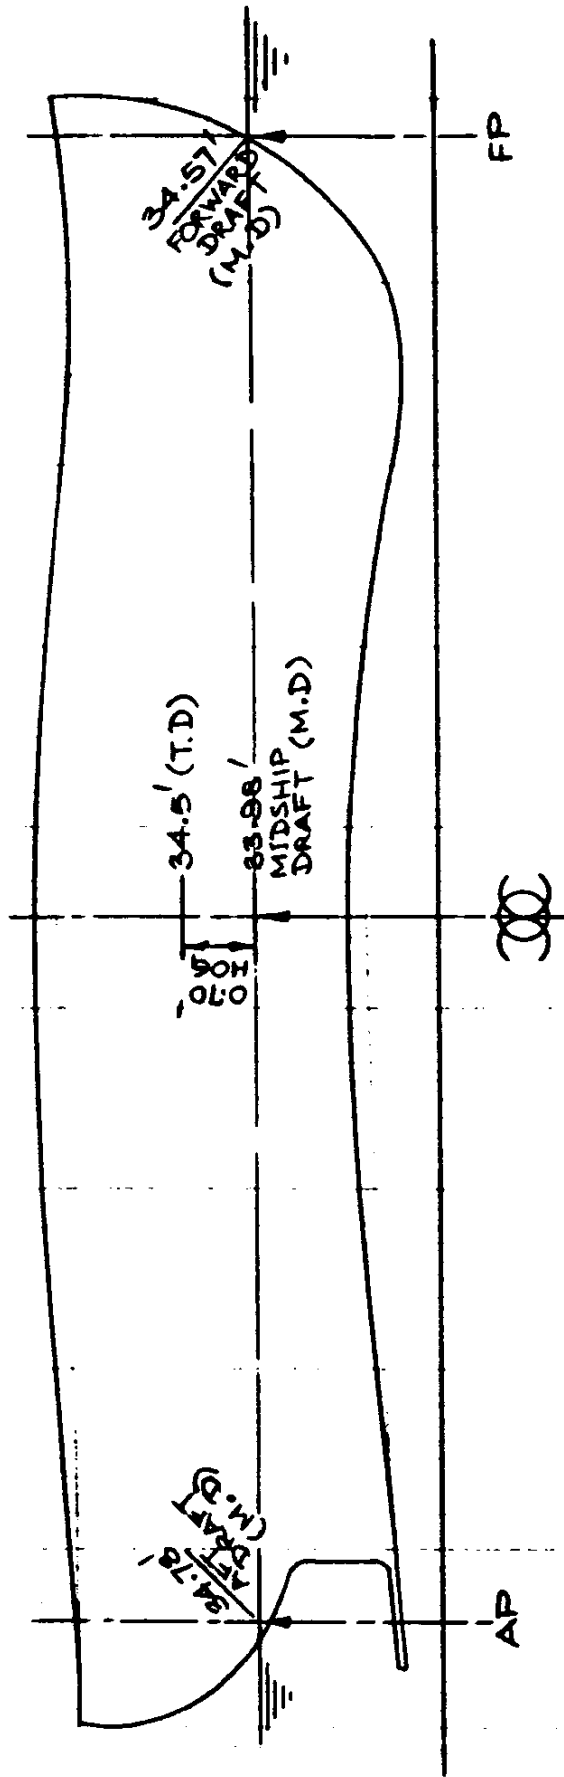
SKETCH ILLUSTRATING HOGGING EFFECT

Mean Midship Draft Between Forward and Aft = 34.68'
 From above, the Ship is Hogging by (34.68'-33.98') = 0.70'
 = 8-1/2"

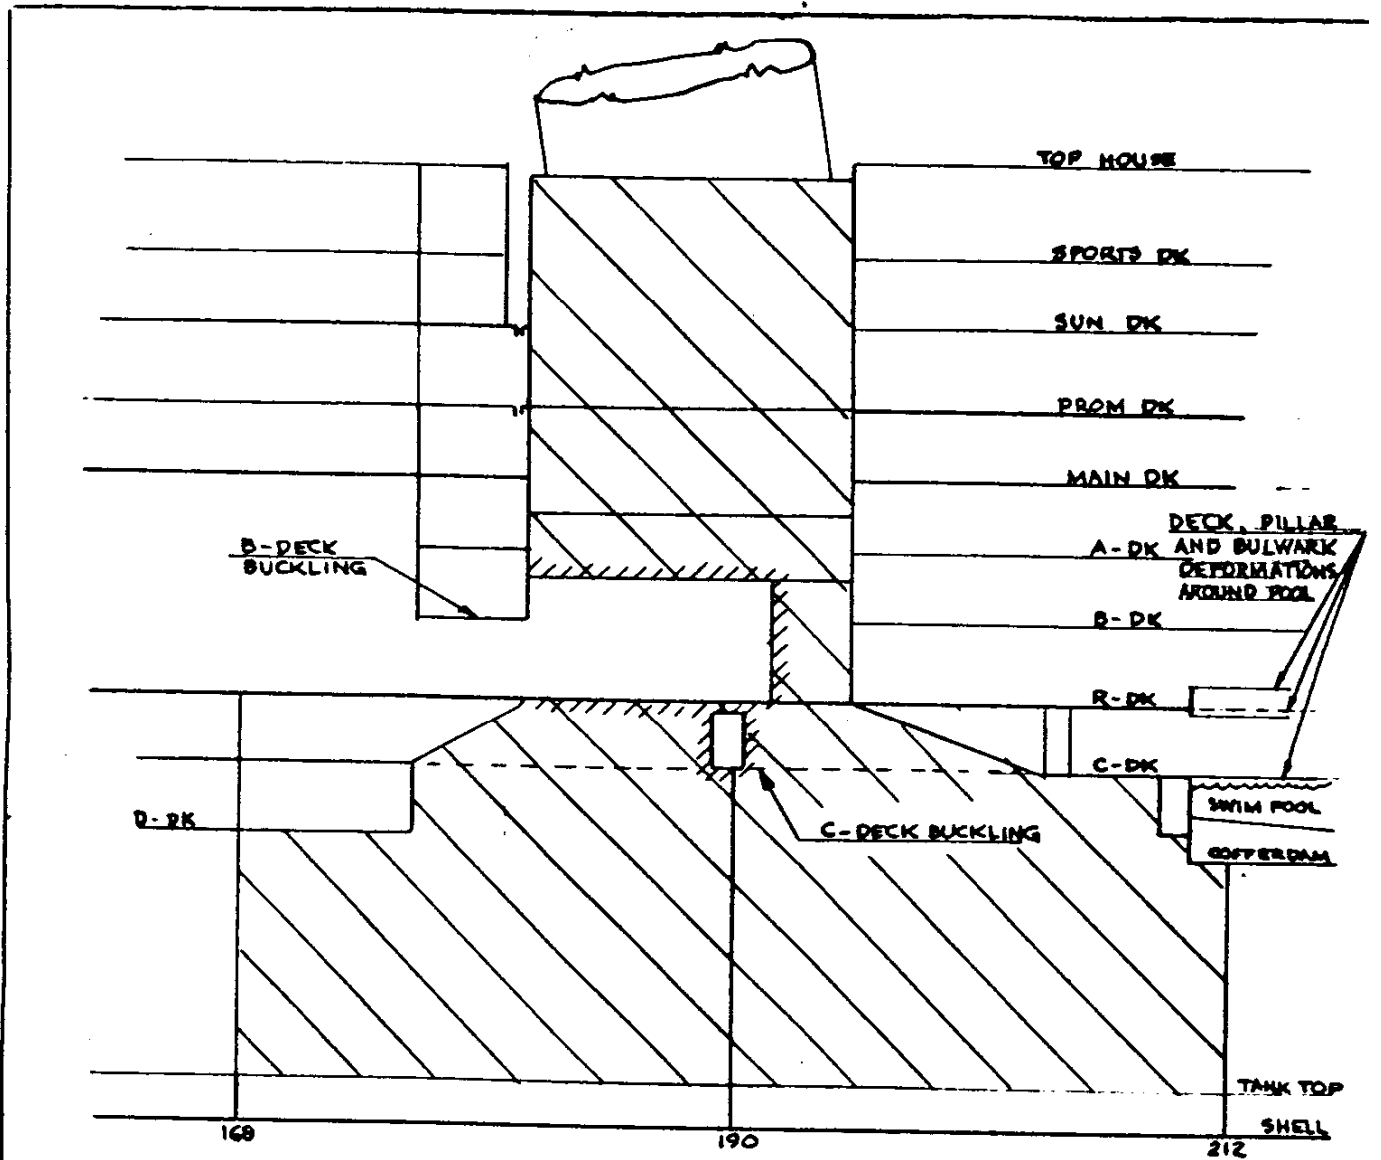
QUEEN MARY - CONVERTED CONDITION

UPTAKE CORE STRUCTURE CUT AWAY FOR WINDSOR RM. (NOTE: STAN. NOT SHOWN), R-DK FILLED-IN SOLID, ARCHES CUT FOR TOUR.

Since any stiffening or cross bracing in the middle of the Windsor Room would be unacceptable, it is recommended to just keep a periodic review of the deck area. It is not anticipated that the buckling and distortion will continue if no additional loads or excess hogging conditions occur and if the fendering system is modified to use rubber fenders. Recommend areas be paved over the ripples on "B"-Deck to eliminate possible tripping hazards.

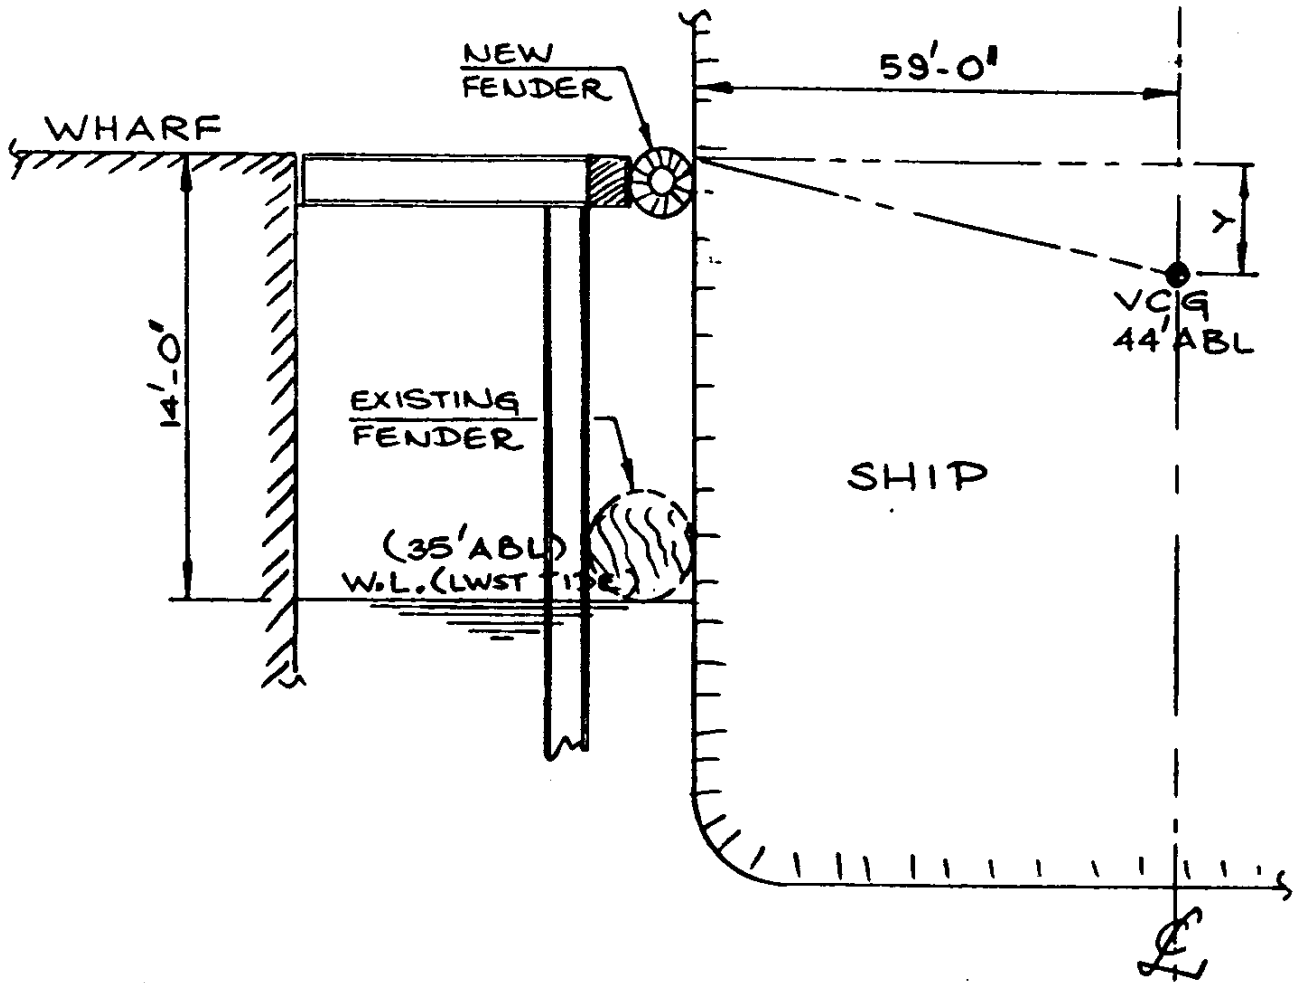
SECTION VIEW LOOKING FORWARD OF SHIP

(Recommended location of fenders)

It is recommended that if the Queen Mary should be moved or relocated, provisions should be made to install rubber fenders on both aft and forward steel fender structures as outlined in the following RIC Sketch.

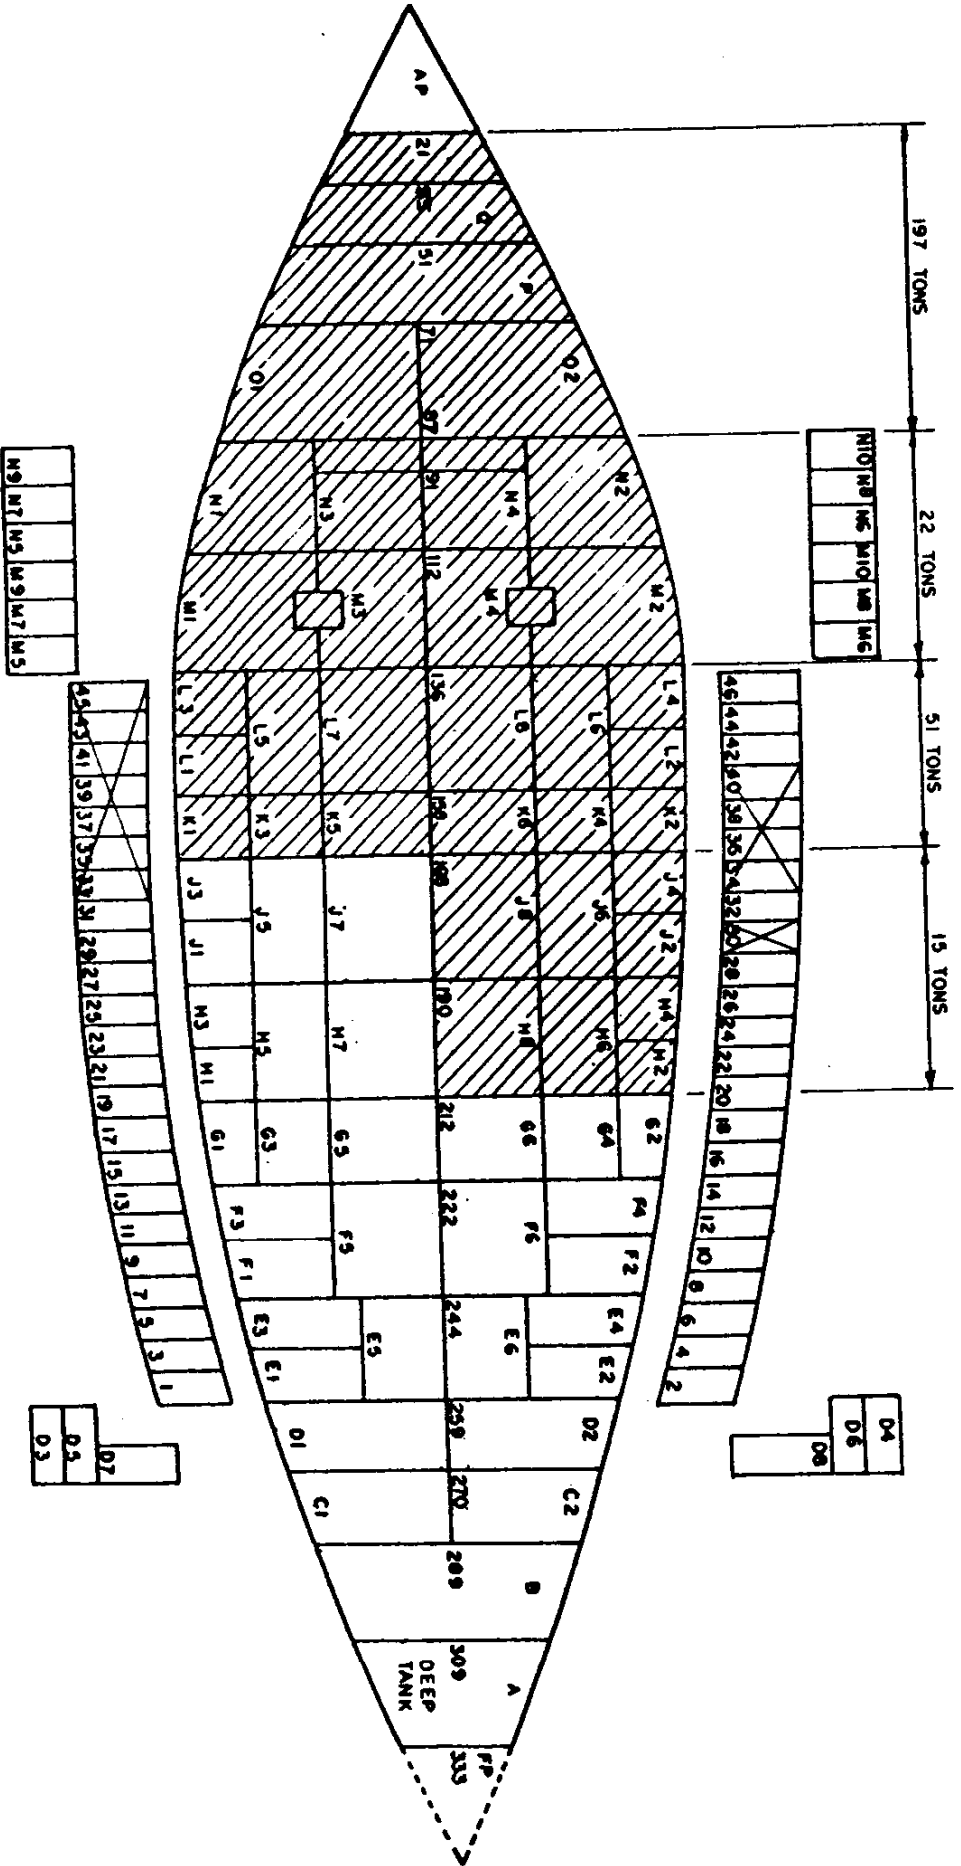
STANDING WATER ABOVE TANK TOPS

There are several areas at the tank top level which have from 6-inches to 18-inches of water. As far as can be determined, the bulk of this water is coming from air conditioning units discharging the condensate drains either directly or indirectly to the bilge area, creating a corrosion problem. Some of the water is from leaking piping in the sewage tank rooms. In one area, the Fan Room on "R" Deck, Frame 200 (under the stairs), a hole has been made in the deck to relieve the puddling of water in the space. This water finds its way through the overhead of what was Fire Room No. 3, then drips down into the bilge area. This space was the worst of the air conditioning spaces surveyed, but is indicative of the extent of the problem.

To keep the bilge area dry, first of all the water from the air conditioning units must be eliminated. This can be done by rerouting the condensate drains to either weather or interior deck drains for units located above the waterline. For those units located below the waterline, the condensate can be drained into small sump tanks equipped with a float operated pump to discharge overboard. Alarms would be installed to warn maintenance personnel of a pumping failure. All other piping leaks should be rectified to keep water out of the bilge area.

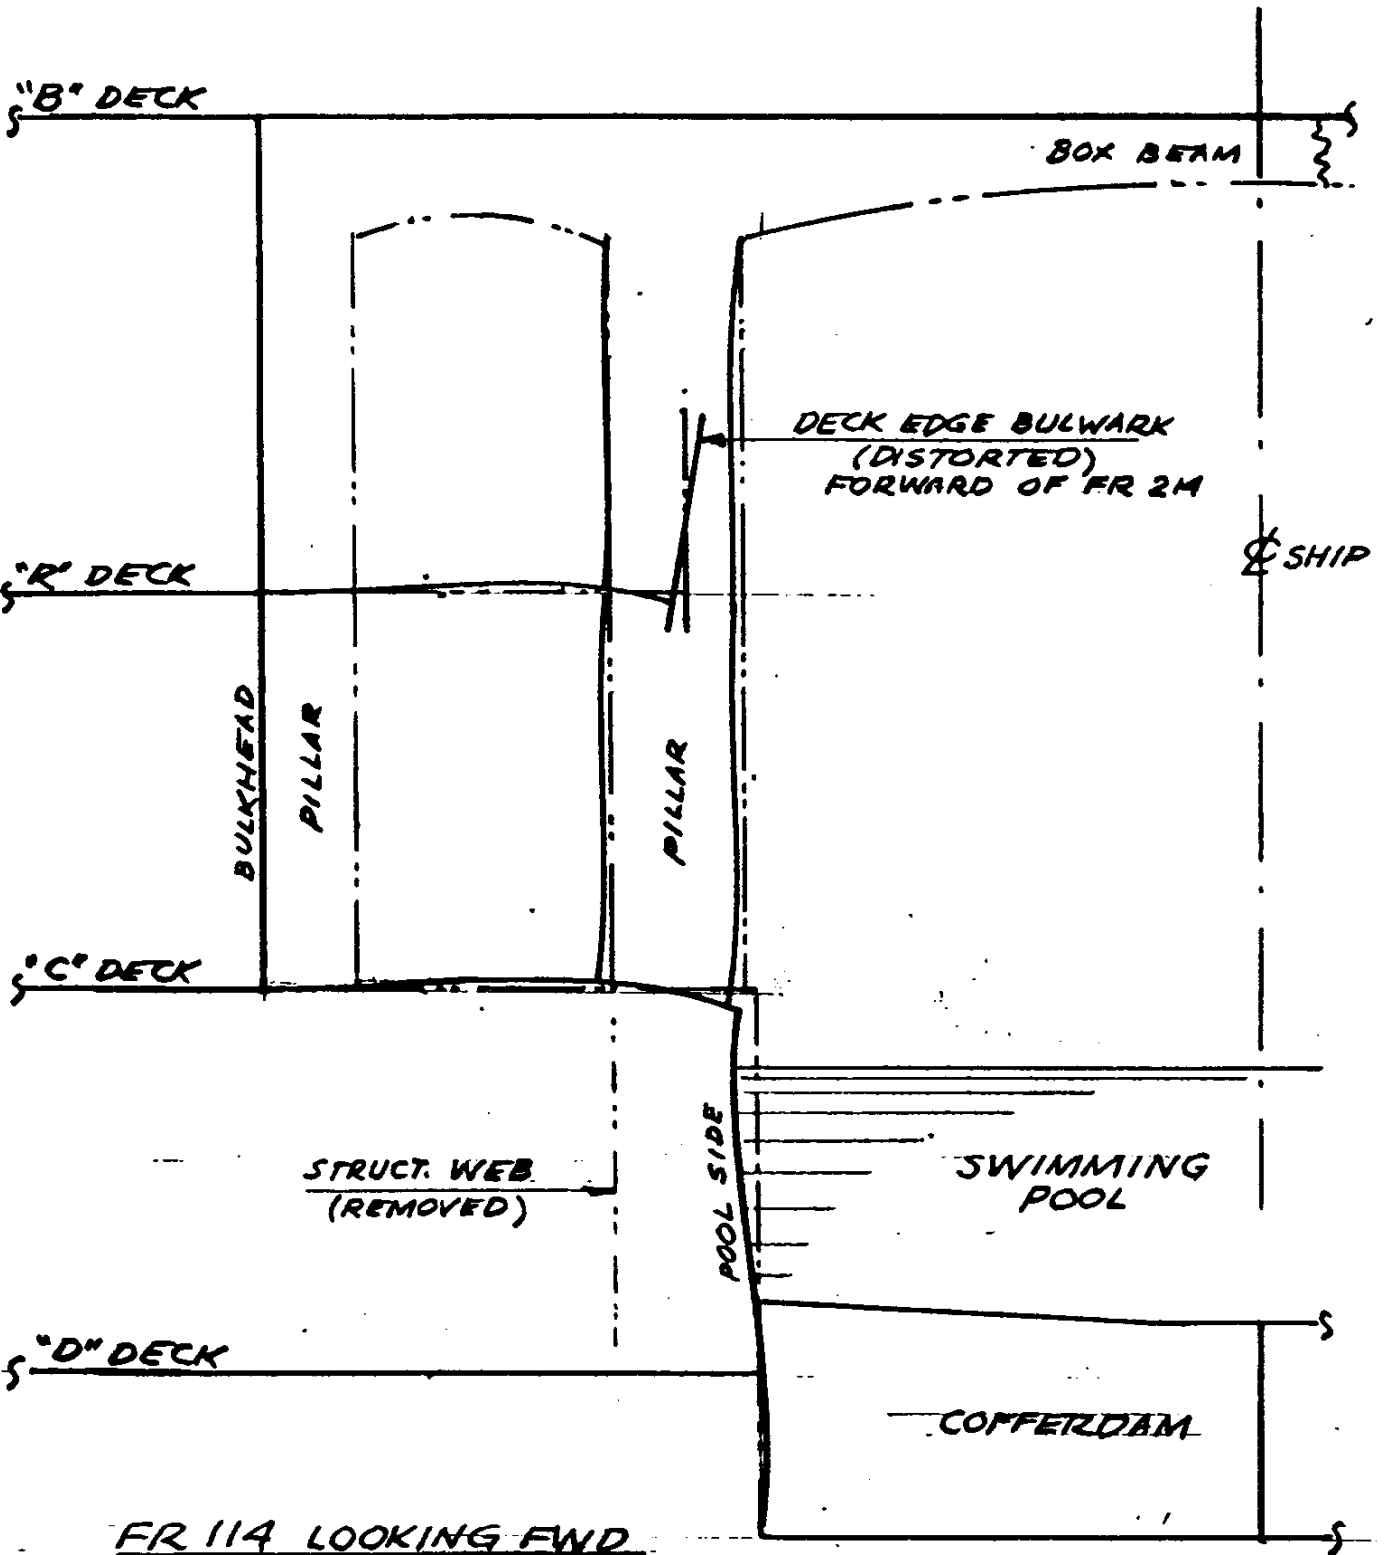
FR 114 LOOKING FWD
STRUCTURAL DEFLECTIONS SHOWN DUE TO WATER PRESSURE
(EXAGGERATED VIEW)

Due to these facts the decking on the port side was sagged and created the cracks on the tiles and cements.

Replacement of the web frame at Frame 214 should be mandatory prior to filling the pool with water again.

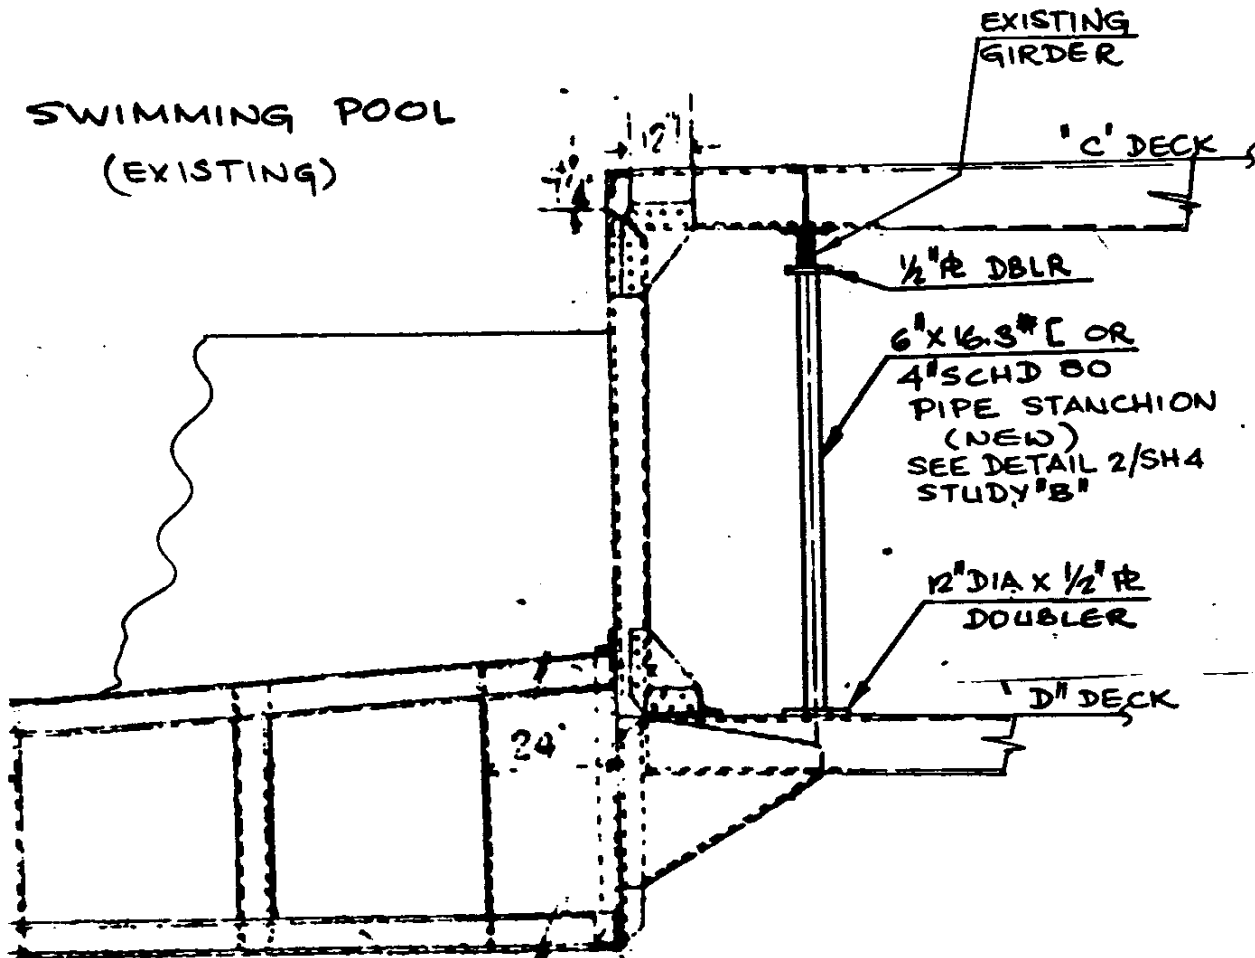
SECTION AT FR 216

- a. Due to the increment of water level by about 6 inches, the load acting on the port side of the plate is increased by 25.4 %.
- b. Due to corrosion on the side plates (50% deterioration), the stiffeners and webs lose their strength by about 12.3 % and 10.7 % respectively.
- c. Due to the lengthening of the span, the port side deck girder loses its strength by about 47.4 % and consequently loses the strength of the beams near the center of the girder by about 66.8 %.
