**QUEEN MARY**

**ANALYSIS OF THE PHYSICAL CONDITION**

VOLUME III  
COST/ENGINEERING

**JULY 1992**

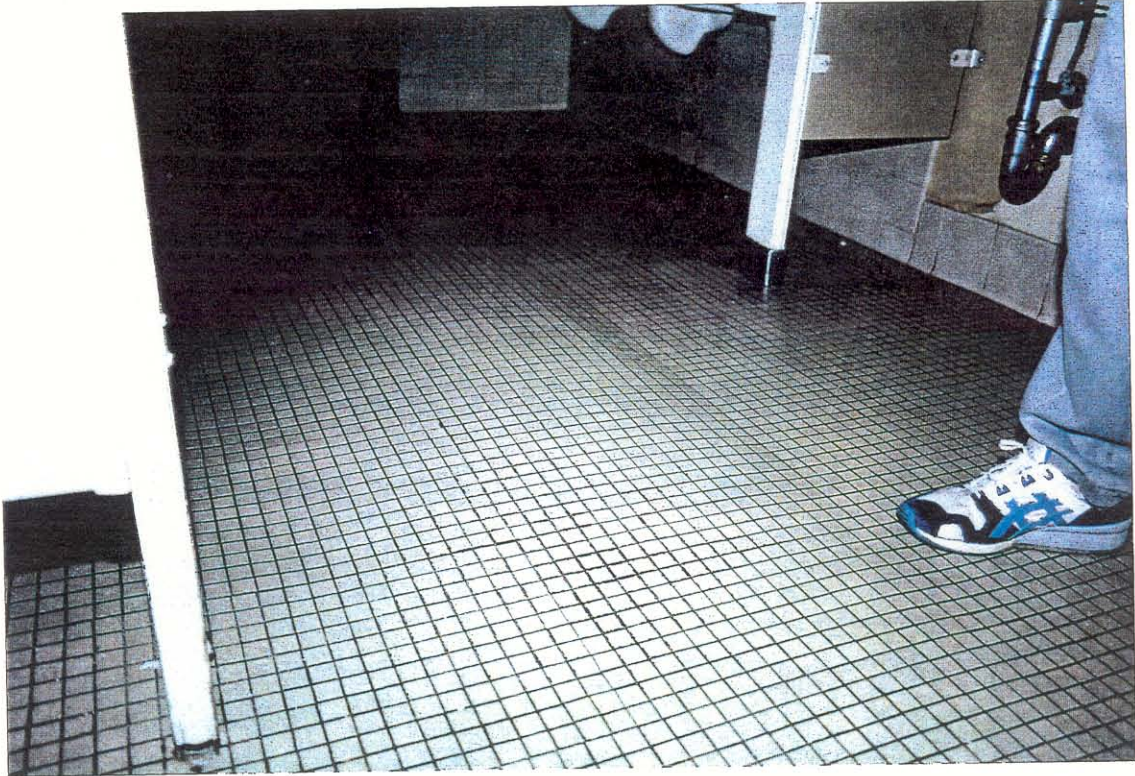
The buckled "A" deck at frames 255 - 258 is located in a public restroom. Recommended repairs would be the installation of a 3", schedule 40 pipe stanchion between "A" deck and "B" deck at frame 257. Retile floor area as necessary.

**"A" DECK RESTROOM - FR. 255 - 258**

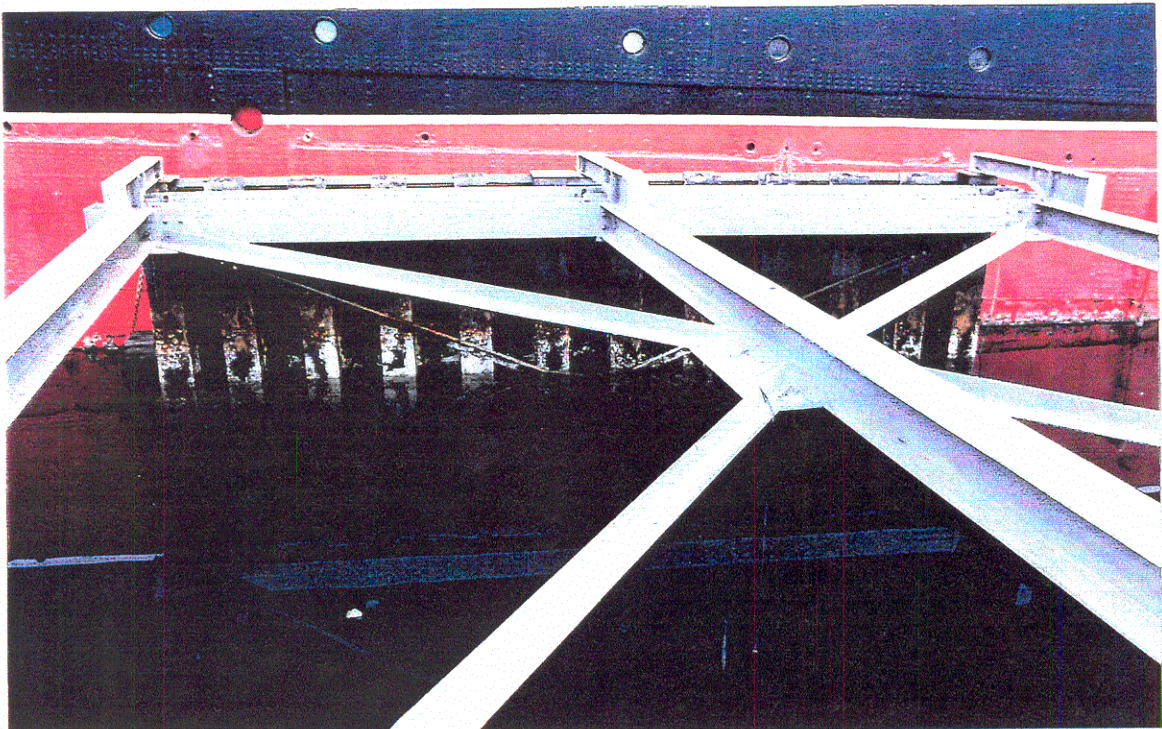
Inspections revealed that the coating has deteriorated and disbanded and is not effectively coating the structure in the splash zone. To inhibit corrosion of the wetted surface of the structure at the waterline at various tide levels, requires corrective welding and reapplication of the corrosion resistant coating. Cathodic protection is not effective in areas such as the splash zone which are not completely submerged.

**BREASTING STRUCTURE**

The Breasting Structures should be sandblasted and re-coated to inhibit future corrosion.

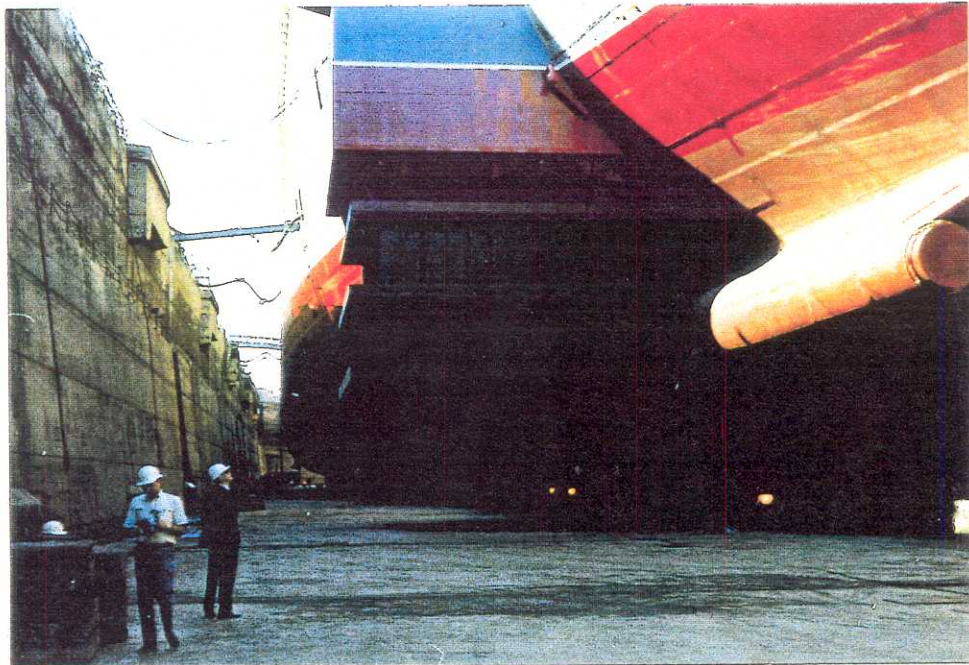
Interior and exterior sections of the propeller box welding seams, are deteriorated and will require future rewelding. This will require the services of an underwater diver to clean the exterior areas and reweld. Interior areas will require the removal of water from the box, erection of staging and welding of seams.

**PROPELLER BOX**

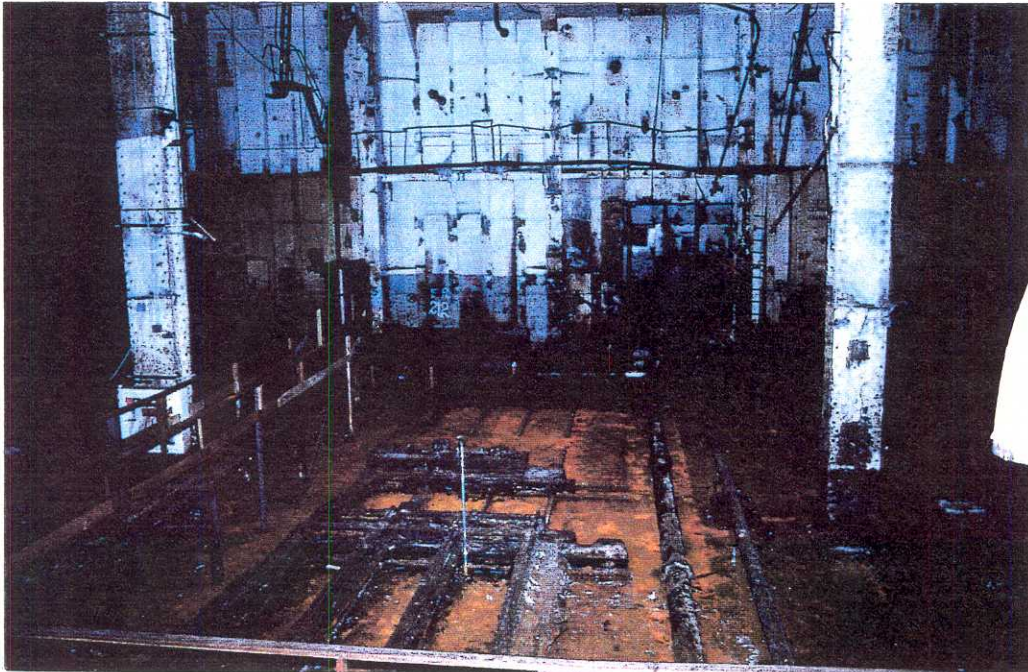
The Boiler Room, Generator and forward Engine room frames 112 to 289 are contaminated with ACM and therefore, unavailable for close inspection and Audio Gauging of tank tops to determine plate thickness. During the past number of years contaminated water, trash, debris, and dissimilar metals, have laid in the bilge area causing considerable corrosive action to the tank tops and structures.

**BOILER ROOM No. 3  
AND DOUBLE BOTTOM TANK TOPS**

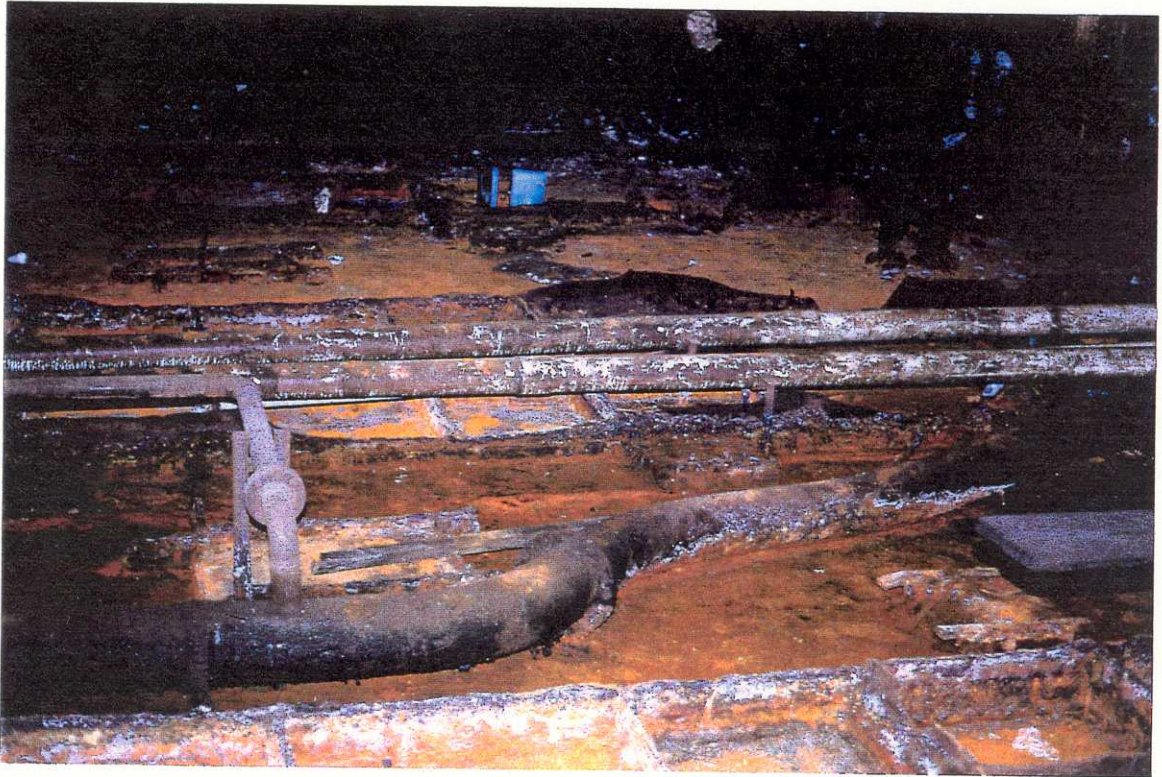
The contaminated water has been removed from the boiler room bilge area and visual inspections indicate considerable corrosion has occurred to tank tops and structures.

**FWD TURBO GENERATOR ROOM - BILGE**

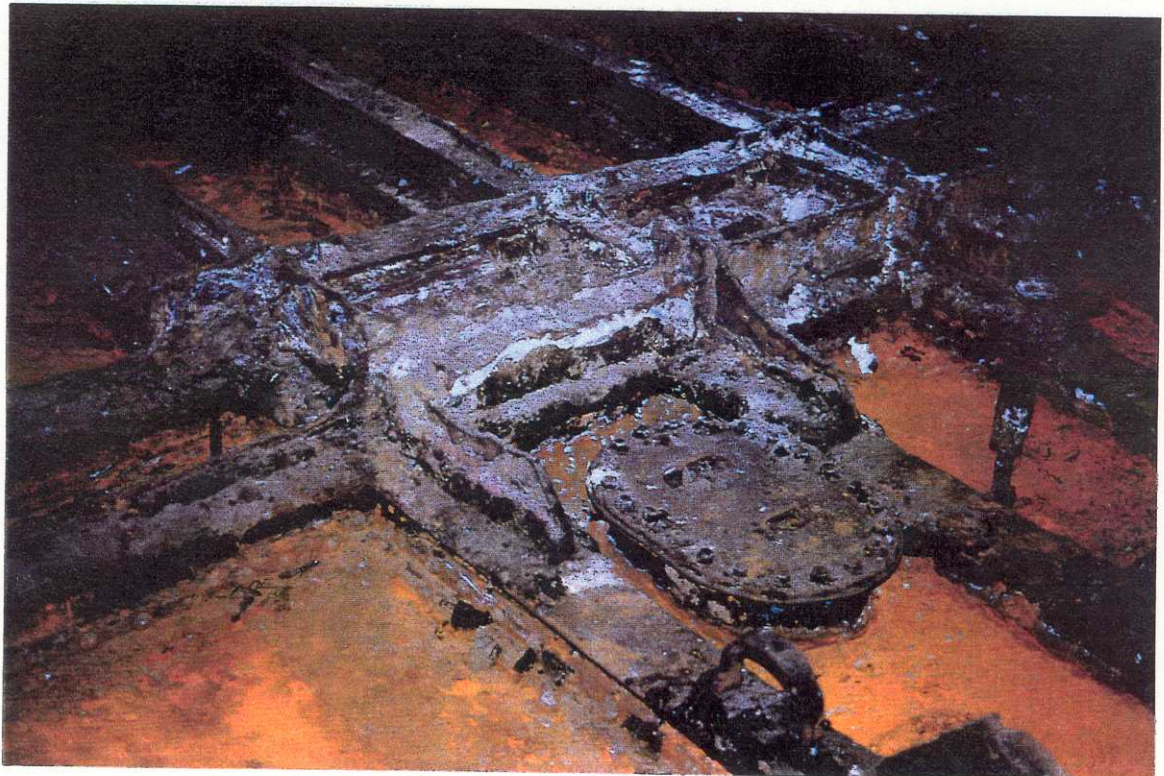
**BOILER FOUNDATION  
AND  
ACCESS TO DOUBLE BOTTOM TANKS**

An immediate concern should be to remove the Asbestos Containing Materials, and sandblast and paint to further reduce deterioration of the plates and structure. As shown in the photographs, there is no watertight integrity within the respective compartments because of the removal of portions of the watertight bulkheads. Should the vessel for some reason incur a serious, fast flowing leak, damage control in limiting the compartments to be flooded would be non-existent. A serious, unmanageable leak would most likely cause the structure to sink.

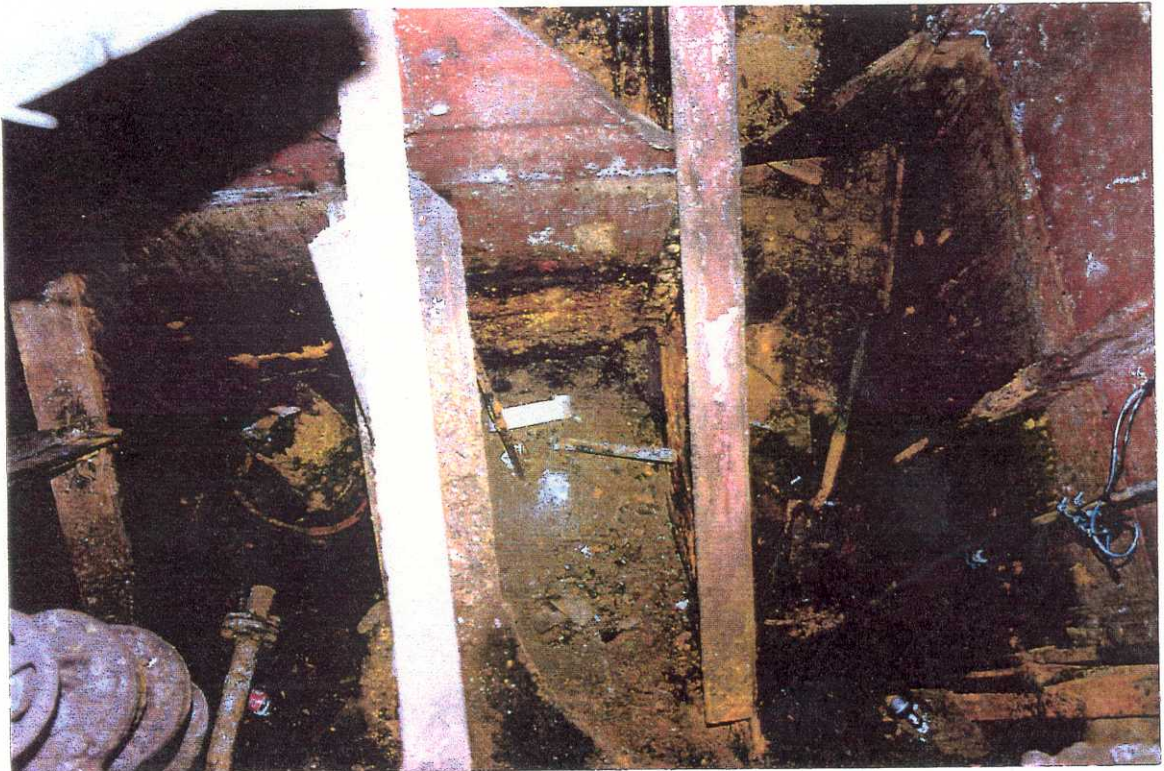
The aft section of the Bilge, until recently, had also been filled with contaminated water, debris, trash and dissimilar metals which has caused extensive corrosion to the hull plating, rivets and structures. The majority of contaminated ballast water in the double bottom tanks, has been removed and drilling mud has been inserted as ballast in the double bottom tanks. Trash, debris and dissimilar metals are still present in the bilge aft, thus, a corrosive action and further deterioration of plating, rivets and structure still exists.

**BILGE DETERIORATION  
CENTERLINE / AFT**

This area also contains loose ACM.

Removal of ACM and trash from the after section of the vessel should also be initiated. Until this area is cleaned and sandblasted, readings cannot be taken in the critical areas. The areas above the contaminated bilges indicate a corrosion loss of approximately 15 %.

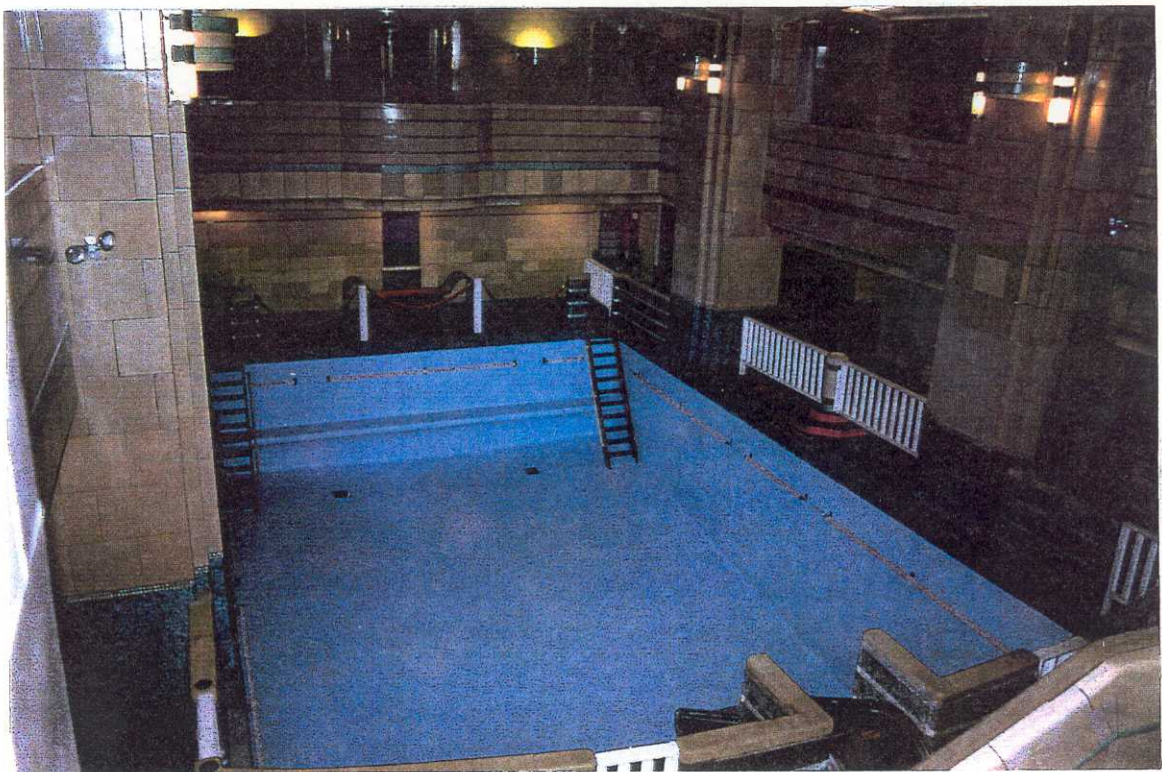
1<sup>ST</sup> CLASS SWIMMING POOL

The pool is located between "C" and "D" Deck between frames 212 to 222 at the centerline of the structure. The top of the pool and exposed structures on or above are covered with decorated tiles about one inch thick. Severe cracking and deformation of the tiles and concrete underlayment occur when the pool is filled with water.

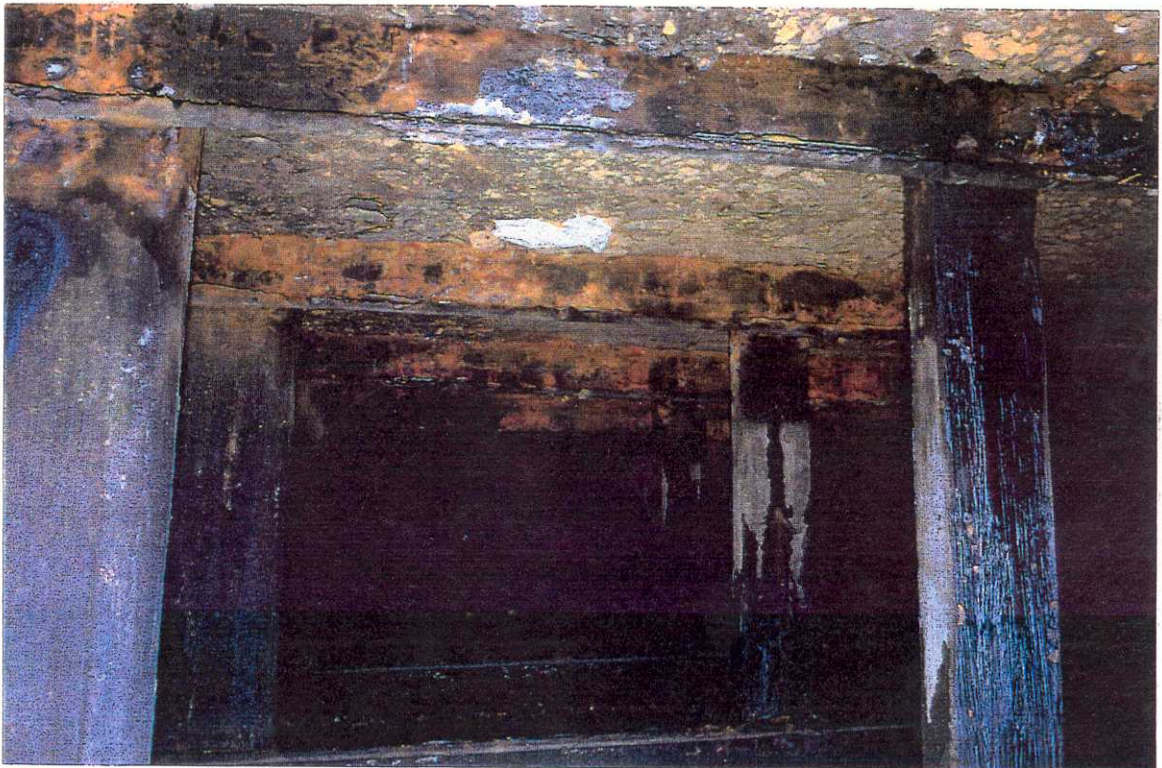
Investigations of the Pool Complex revealed that due to the number of years of continuously using salt water in the pool combined with the heat generated by operation of the generators below, and the moisture trapped in the enclosed structure beneath the pool, the steel lining and structural members of the cofferdam of the pool have severely deteriorated. Should the pool be considered operational at some future time, expensive repairs would be required. Additionally several supporting structures on the port side of the pool structure were removed during the conversion to accommodate the application of cement on the floor of "D" deck. This removed structural support, adds significantly to the movement of the pool and has created the cracks to the pool cement and tile. This movement appears to be most prevalent when the pool is filled.

**STRUCTURAL FOUNDATION  
UNDER 1<sup>ST</sup> CLASS POOL**

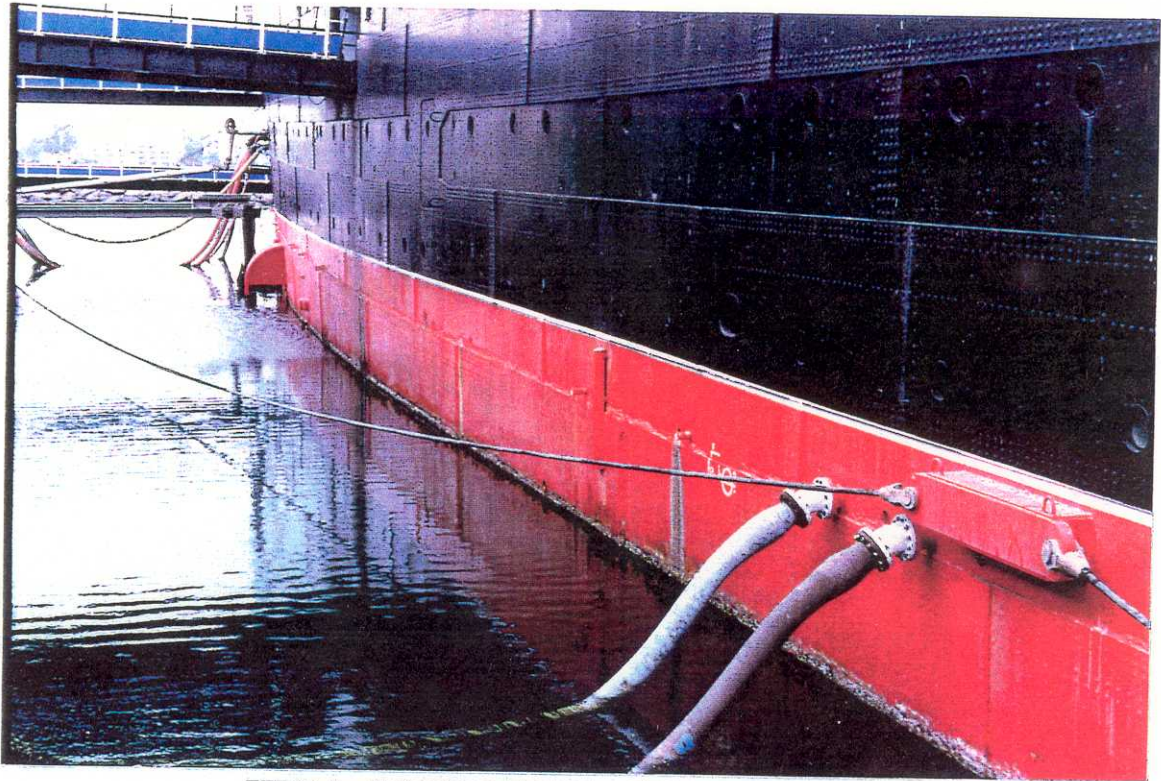
During the conversion period of the Queen Mary, Rados developed a "Hull Corrosion Study" for the Long Beach Queen Mary Department for purposes of determining theoretically the projected amount of plate wastage (deterioration) that would occur during the life of the vessel. The conclusion of the study revealed that within a period of twenty-five (25) years the Queen should be re-drydocked to inspect and repair deteriorated plating, rivets, and plate inserts that have covered the one-hundred (100) sea chest openings. The hull structure should be cleaned, sandblasted, and painted within the next 3 to 5 years.

**HULL CORROSION - SPLASH ZONE**

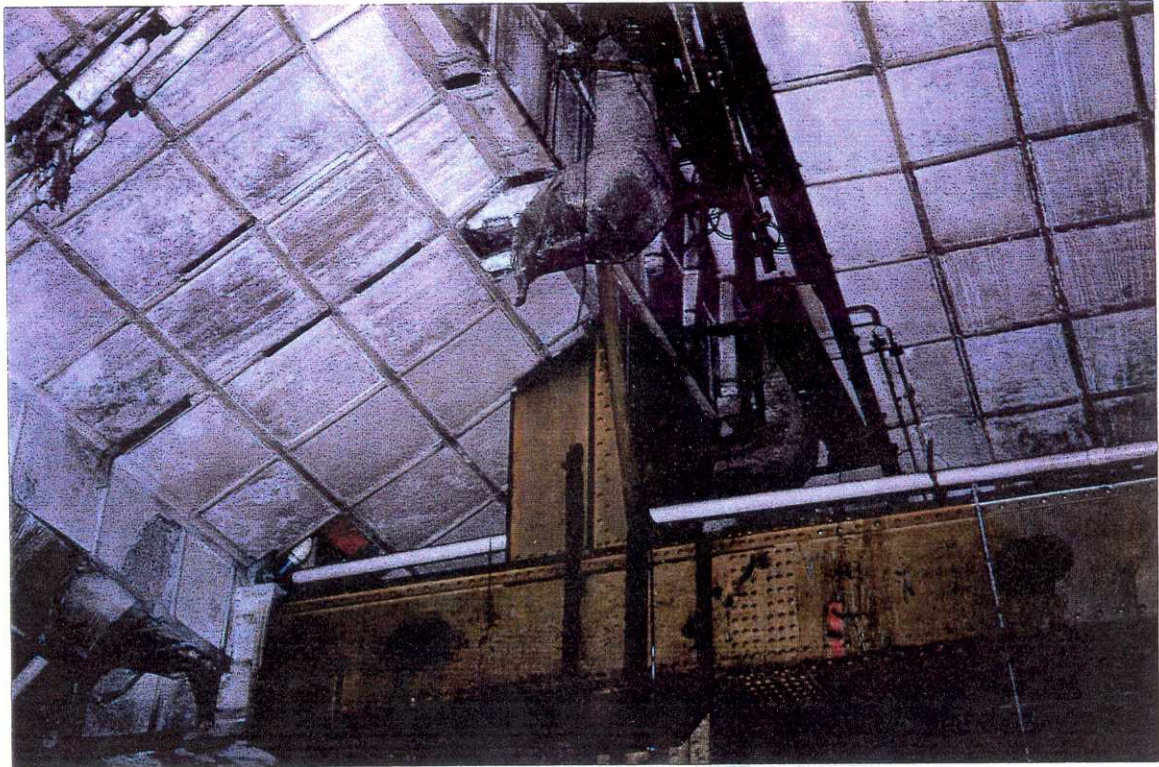
Presently, the majority of the tank top areas are covered with Asbestos Containing Material (ACM). This is due to the ACM panels that were installed in the uptakes (stack area) to provide for heat retention within the machinery spaces and avoid penetration into the staterooms and other areas. This hazardous material would be required to be removed by a qualified firm prior to any work is preformed in these areas.

### ACM PANELS - UPTAKE

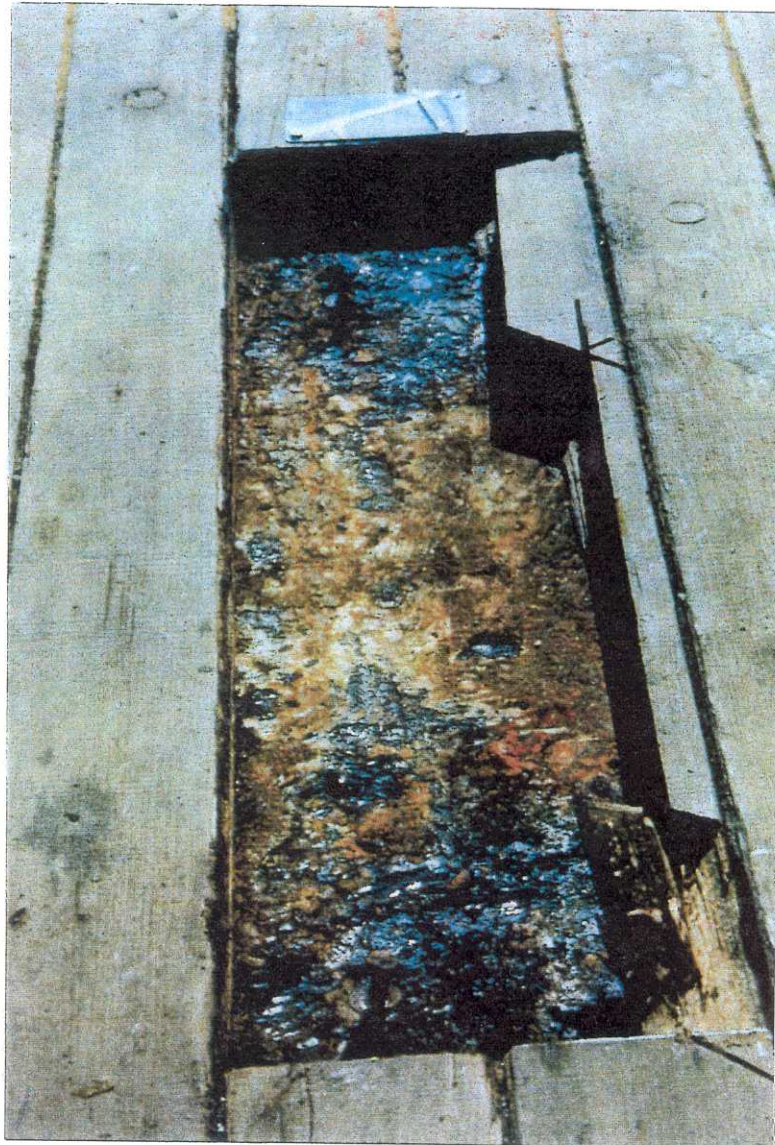
**SECTION OF REMOVED TEAK DECK  
SHOWING CORRODED STEEL DECK PLATING**

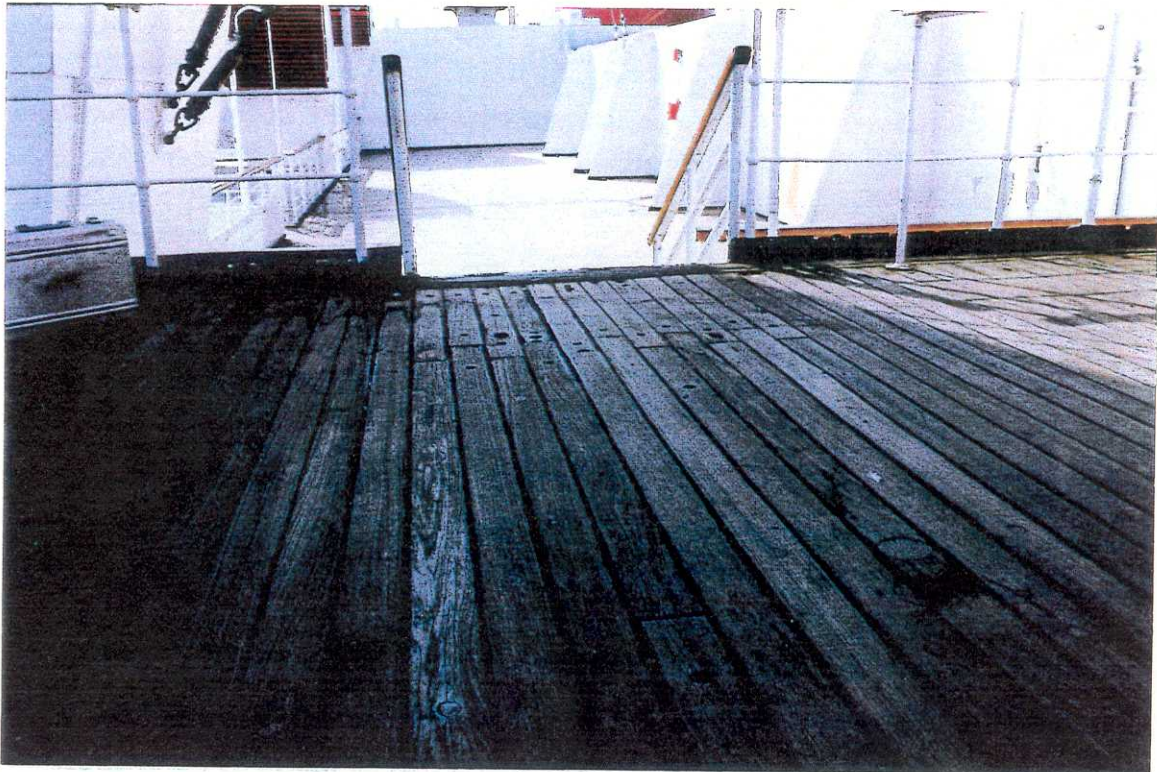
**SPORTS DECK - WEATHERED TEAK DECK**

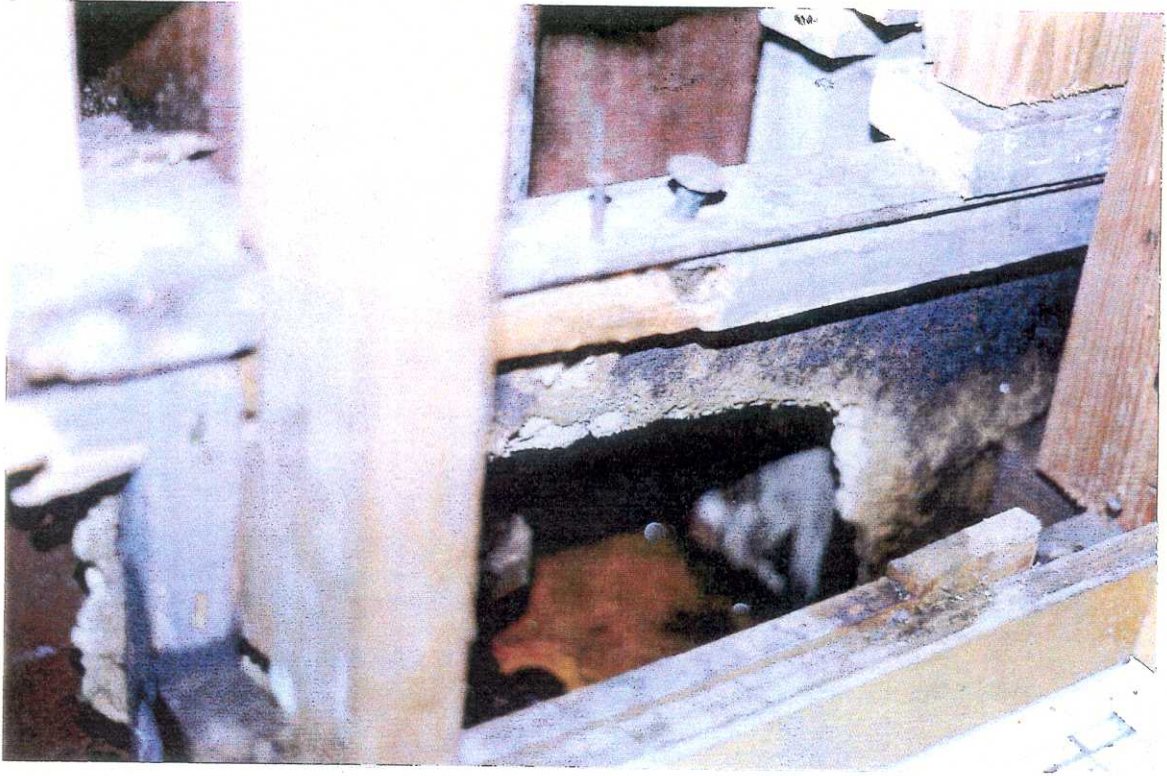
**TYPICAL ASBESTOS INSULATION  
INSIDE WOOD PANELING**

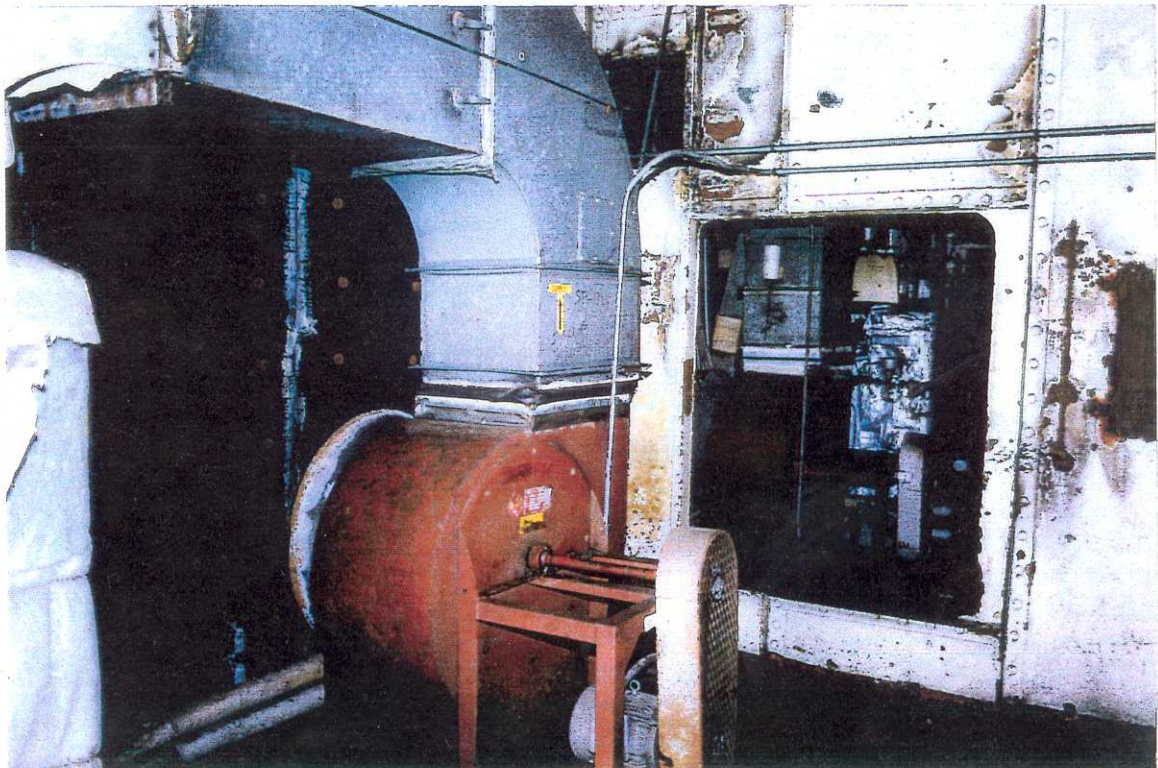
- a. Intake screens are very dirty and in some cases 60% or more clogged with dirt and/or paint which severely restricts the air flow and efficiency.
- b. Systems that have heating and/or cooling coils have clogged or missing air filters.
- c. Flexible rubberized canvas duct connectors have holes, and in some cases are torn or in a deteriorated condition.
- d. Noisy bearings and out of balance fan wheels cause excessive vibration.

**SUPPLY FAN AT FRAME 178**

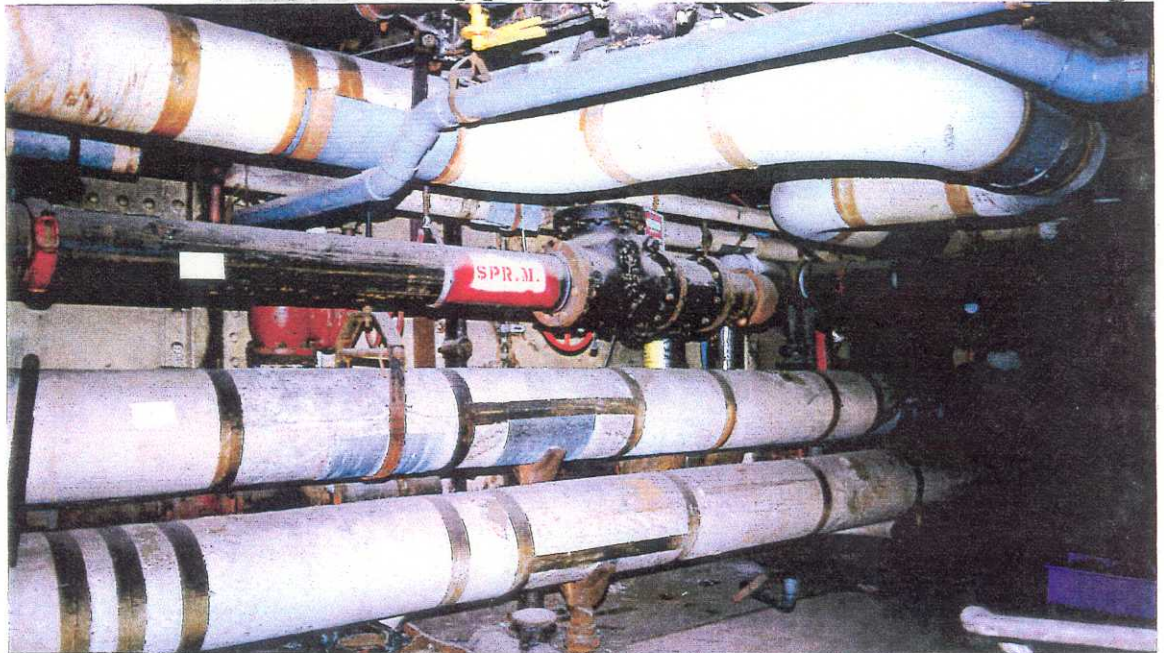
The Firemain and Sprinkler Systems are served from the shore by separate lines. Both systems after many years of use, should be flushed and hydrostatically pressure tested in their entirety plus perform any other test required by the Long Beach Fire Department. Results of these tests will help determine the condition of the systems and the extent of repairs to be made. Should these tests indicate extensive rework, replacement of all piping may be more cost effective for the long term.

**FIREMAIN AND SPRINKLING MAIN  
AT POINT OF HULL PENETRATION**

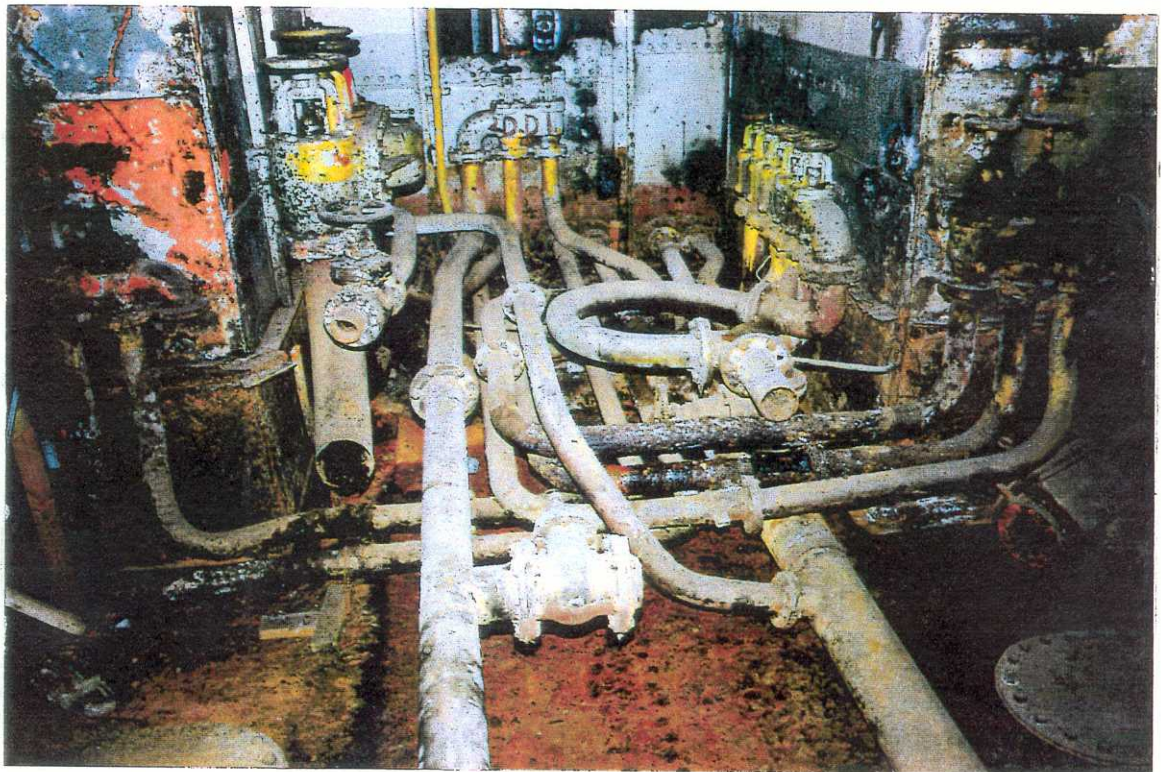
Piping installed during the conversion is PVC mixed with steel, and in fair to good condition. All bilge wells are clean and have water to cover the suction strainer. Bilge piping forward of frame 260 is badly corroded, with some sections completely rusted out, making the system inoperative. Some piping has been replaced at some of the bilge wells. Watertight bulkheads which could ordinarily isolate various areas of the bilges are non-existent, subjecting the ship to total flooding in case of a catastrophic disaster.

**PART OF BILGE PIPING SYSTEM**

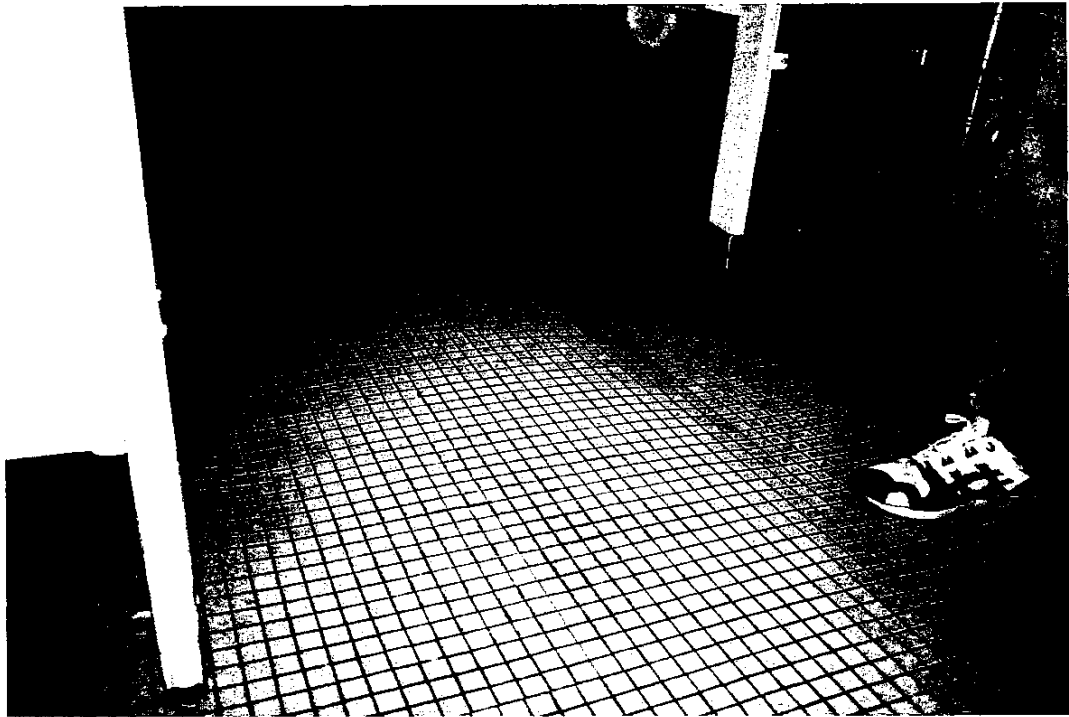
The buckled "A" deck at frames 255 - 258 is located in a public restroom. Recommended repairs would be the installation of a 3", schedule 40 pipe stanchion between "A" deck and "B" deck at frame 257. Retile floor area as necessary.

"A" DECK RESTROOM - FR. 255 - 258

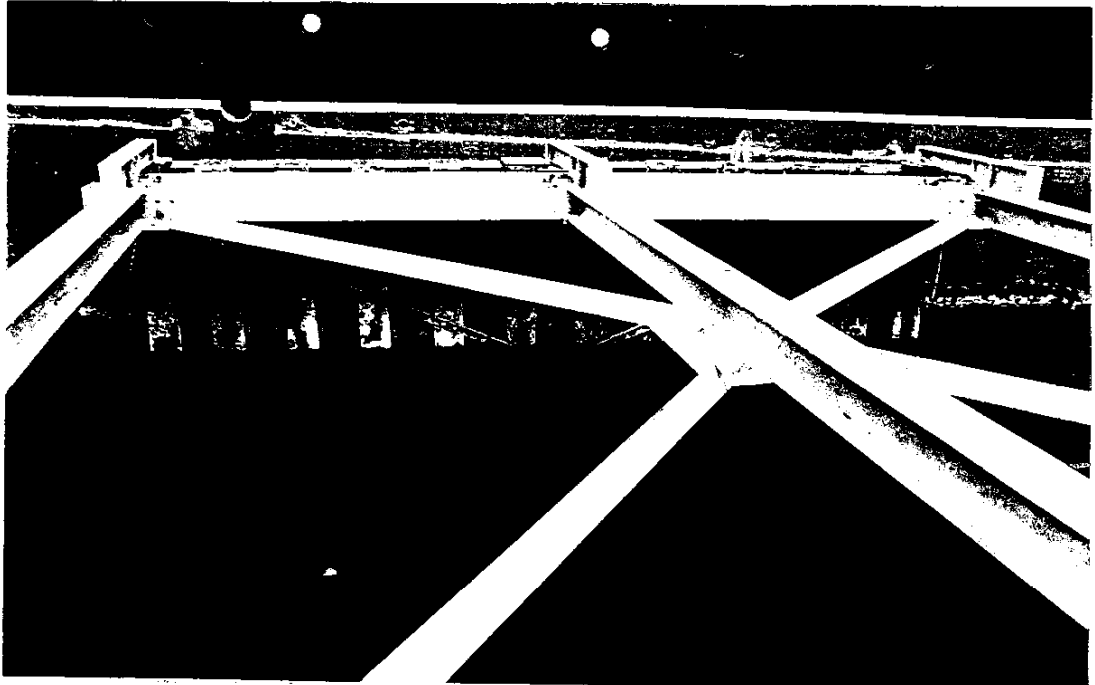
Inspections revealed that the coating has deteriorated and disbanded and is not effectively coating the structure in the splash zone. To inhibit corrosion of the wetted surface of the structure at the waterline at various tide levels, requires corrective welding and reapplication of the corrosion resistant coating. Cathodic protection is not effective in areas such as the splash zone which are not completely submerged.

**BREASTING STRUCTURE**

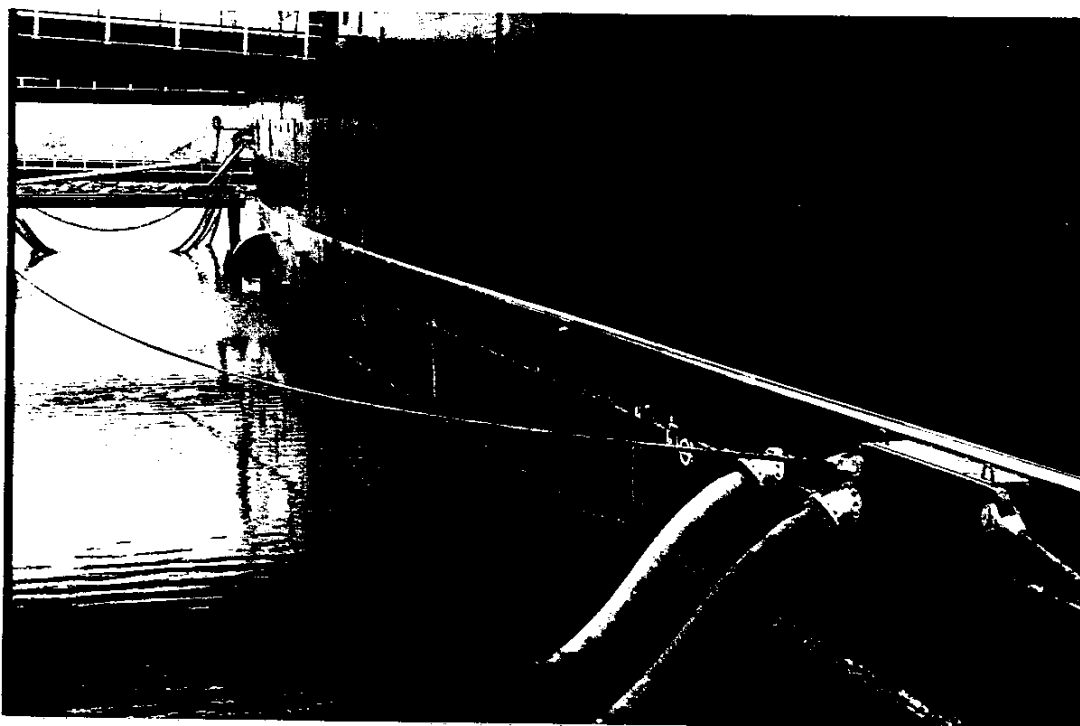
**HULL CORROSION - SPLASH ZONE**
