date November 17, 1992
to Mayor and City Council
from John F. Shirey, Assistant City Manager
subject Queen Mary Hull Condition Survey

CITY OF LONG BEACH
RMS QUEEN MARY
CATHODIC PROTECTION
AND SHELL CONDITION SURVEY
JOB NO. 2369
NOVEMBER 4, 1992

INTERNATIONAL DIVING SERVICES

Submitted: November 13, 1992

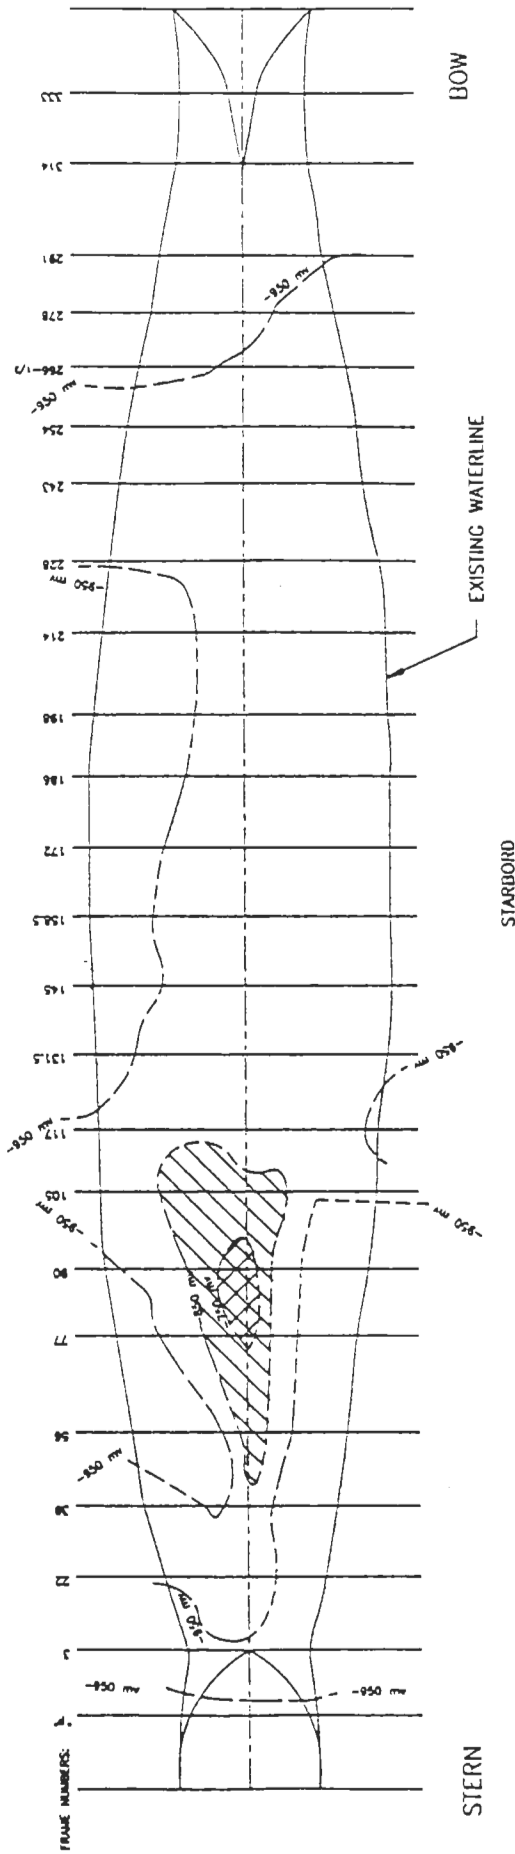
QUEEN MARY SHELL EXPANSION
 WITH
 CATHODIC PROTECTION ISOPLETH
 FOR
 CITY OF LONG BEACH
 SCALE 1" = 80' NOVEMBER 1992

- 2.1.3 **Findings** - The voltage potential measurements ranged from as high as -1.055 mV to as low as -.630 mV. A voltage of potential reading of -.800 mV and lower is consider to be inadequate.

The majority of the measurements were above the -.800 mV mark and the impressed current cathodic protection system currently in use appears to be functioning well and providing adequate protection to the majority of the shell plating.

One zone of low and inadequate coverage was found on the ship's flat bottom, however, between frame #39 and #117 the lack of protection is quite serious and should be corrected as soon as possible. (See the following drawing "Isopleth of Cathodic Voltage Potentials"

- b. Sacrificial Anodes - Replace the depleted sacrificial anodes on seachests and install additional sacrificial anodes in the areas which are now shadowed from the impressed current cathodic protection system.

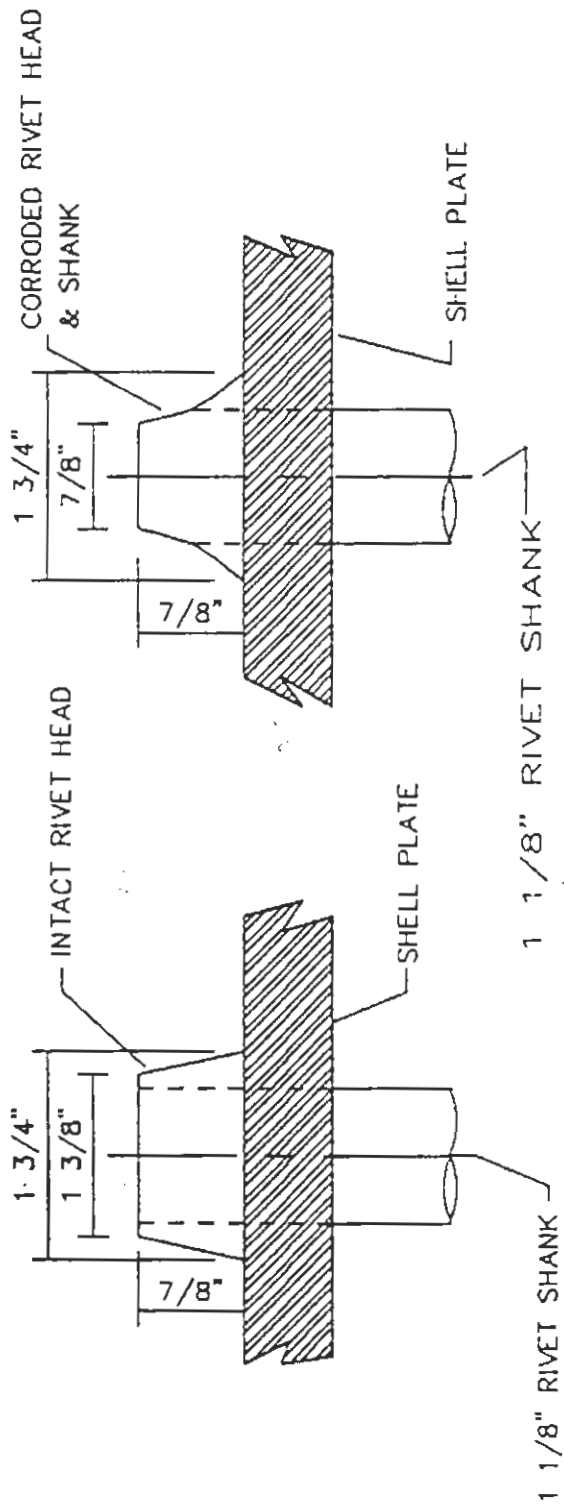
INTERNAL RIVET INSPECTION

Shell rivet heads, showing heavy corrosion, have lost about 78% of their original material. The rivet shank is visible at the top of the head and appears to also have lost some material. The base of the rivet head still maintains the same diameter as the intact head and appears to be tight to the shell plating. Approximately 50% of the rivet / rivet head shear area is still intact. See the rivet inspection drawing at the end of this section.

Scale and rust was removed from the shell plating in thicknesses up to 3/16". The exposed plating, while still retaining fine rust did not exhibit pitting any greater than 1/16". Remaining material at the lap joints appears to still be at least 7/8".

- a. Clean-Up - Remove all scrap material and bilge sludge from all compartments showing deterioration. Sand blast all internal steel plate, shapes, and rivets in way of failed or missing coatings.
- b. Damage Assessment - Perform an engineering study, including non-destructive testing, of the most heavily damaged internal parts of the ship. Where significant material has been lost, determine the scantlings necessary to maintain structural integrity in the ship's current environment and when drydocked. Determine the minimum rivet head material necessary to prevent rivets from pulling out.
