QUEEN MARY HOTEL

- o HULL STRUCTURAL ANALYSIS
- o PIPING AND BALLAST SYSTEMS
- o MAINTENANCE STUDY

RADOS INTERNATIONAL CORPORATION
POST OFFICE BOX 830
SAN PEDRO, CA 90733

DATE: SEPTEMBER 26, 1990

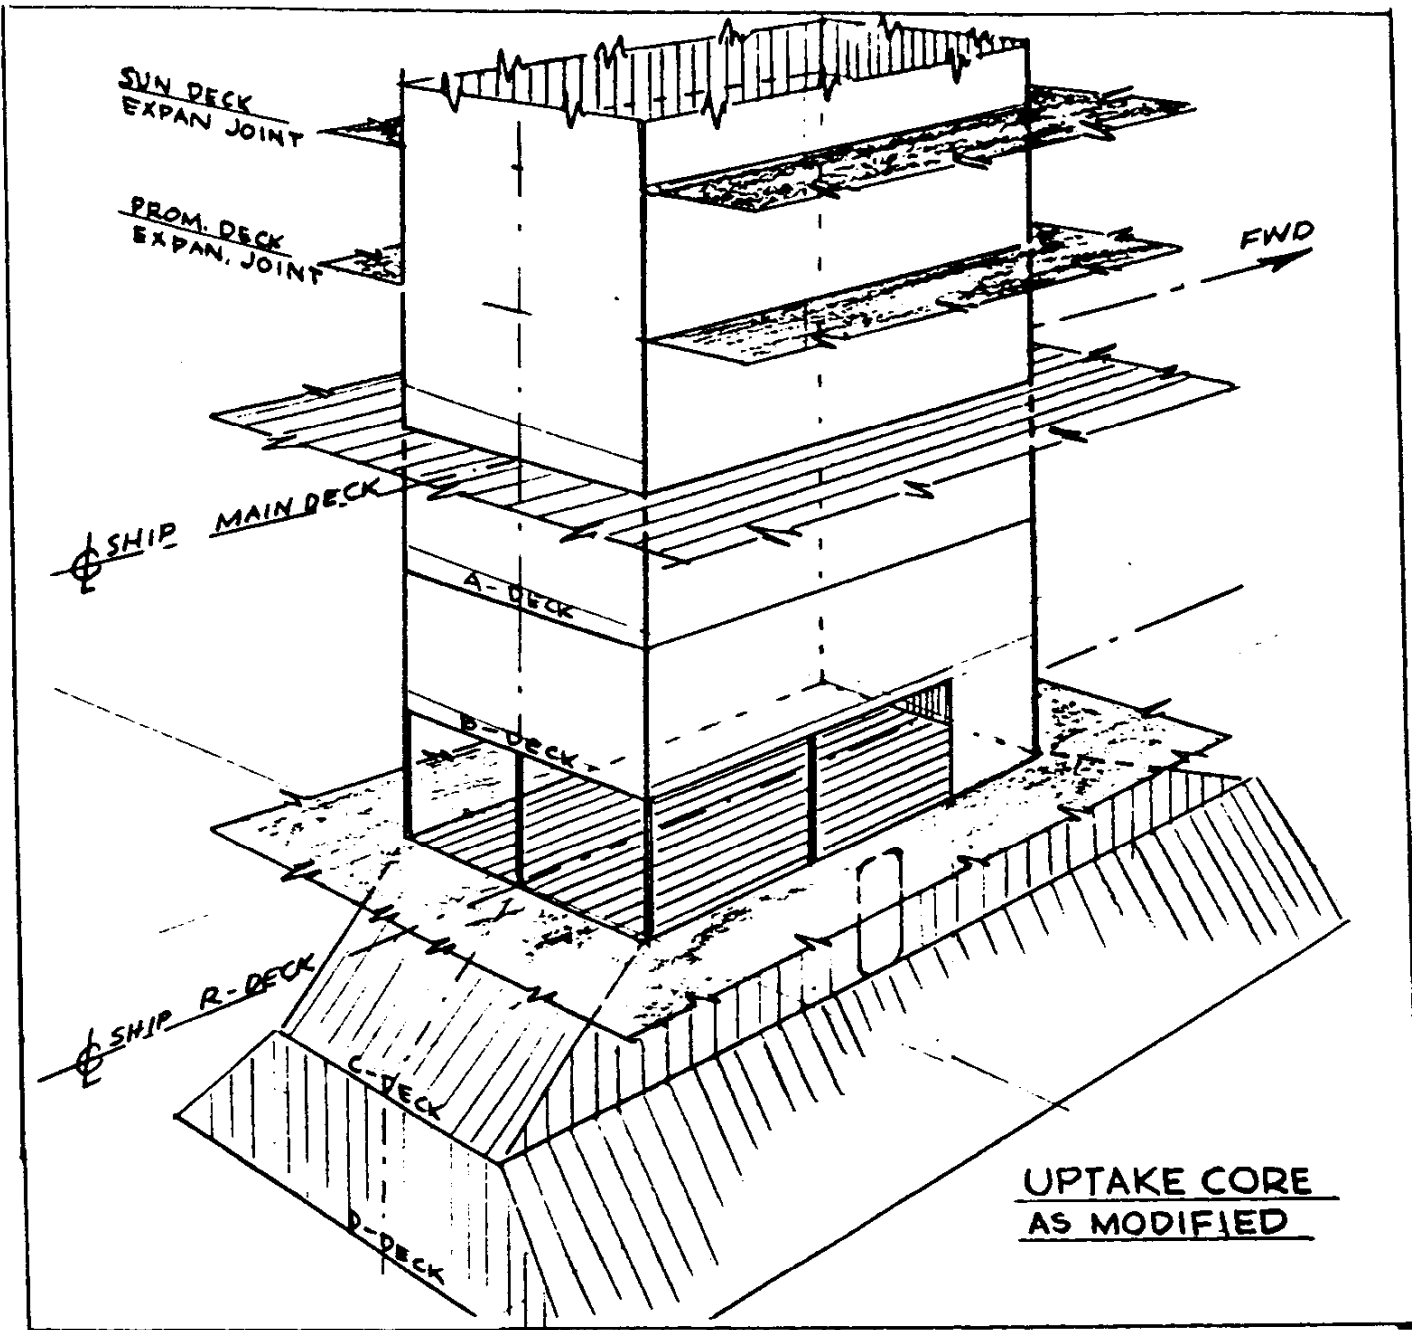
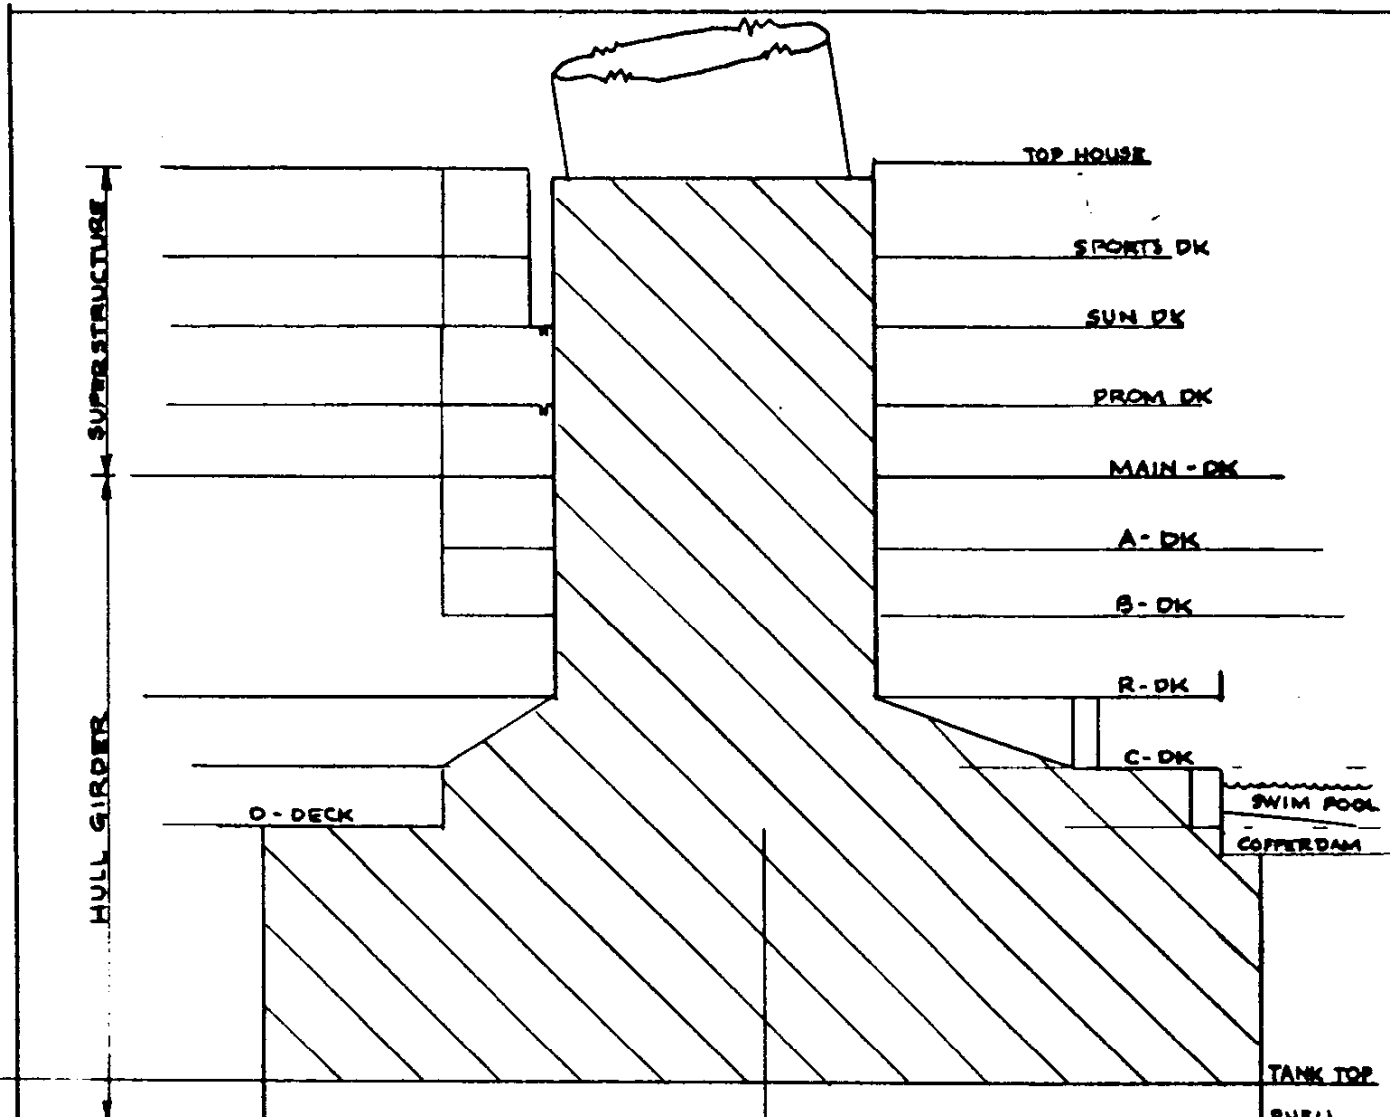
QUEEN MARY INBOARD PROFILE
ORIGINAL STRUCTURE
UPTAKE CORE TO STIFFEN HULL GIRDER

UPTAKE CORE STRUCTURE CUT AWAY FOR WINDSOR RM. (NOTE: STAN. NOT SHOWN), R-DK FILLED-IN SOLID, ARCHES CUT FOR TOUR.

Recommendation:

Since any stiffening or cross bracing in the middle of the Windsor Room would be unacceptable, it is recommended to just keep a periodic review of the deck area. It is not anticipated that the buckling and distortion will continue if no additional loads or excess hogging conditions occur and if the fendering system is modified to use rubber fenders. Recommend areas be paved over the ripples on "B"-Deck to eliminate possible tripping hazards.

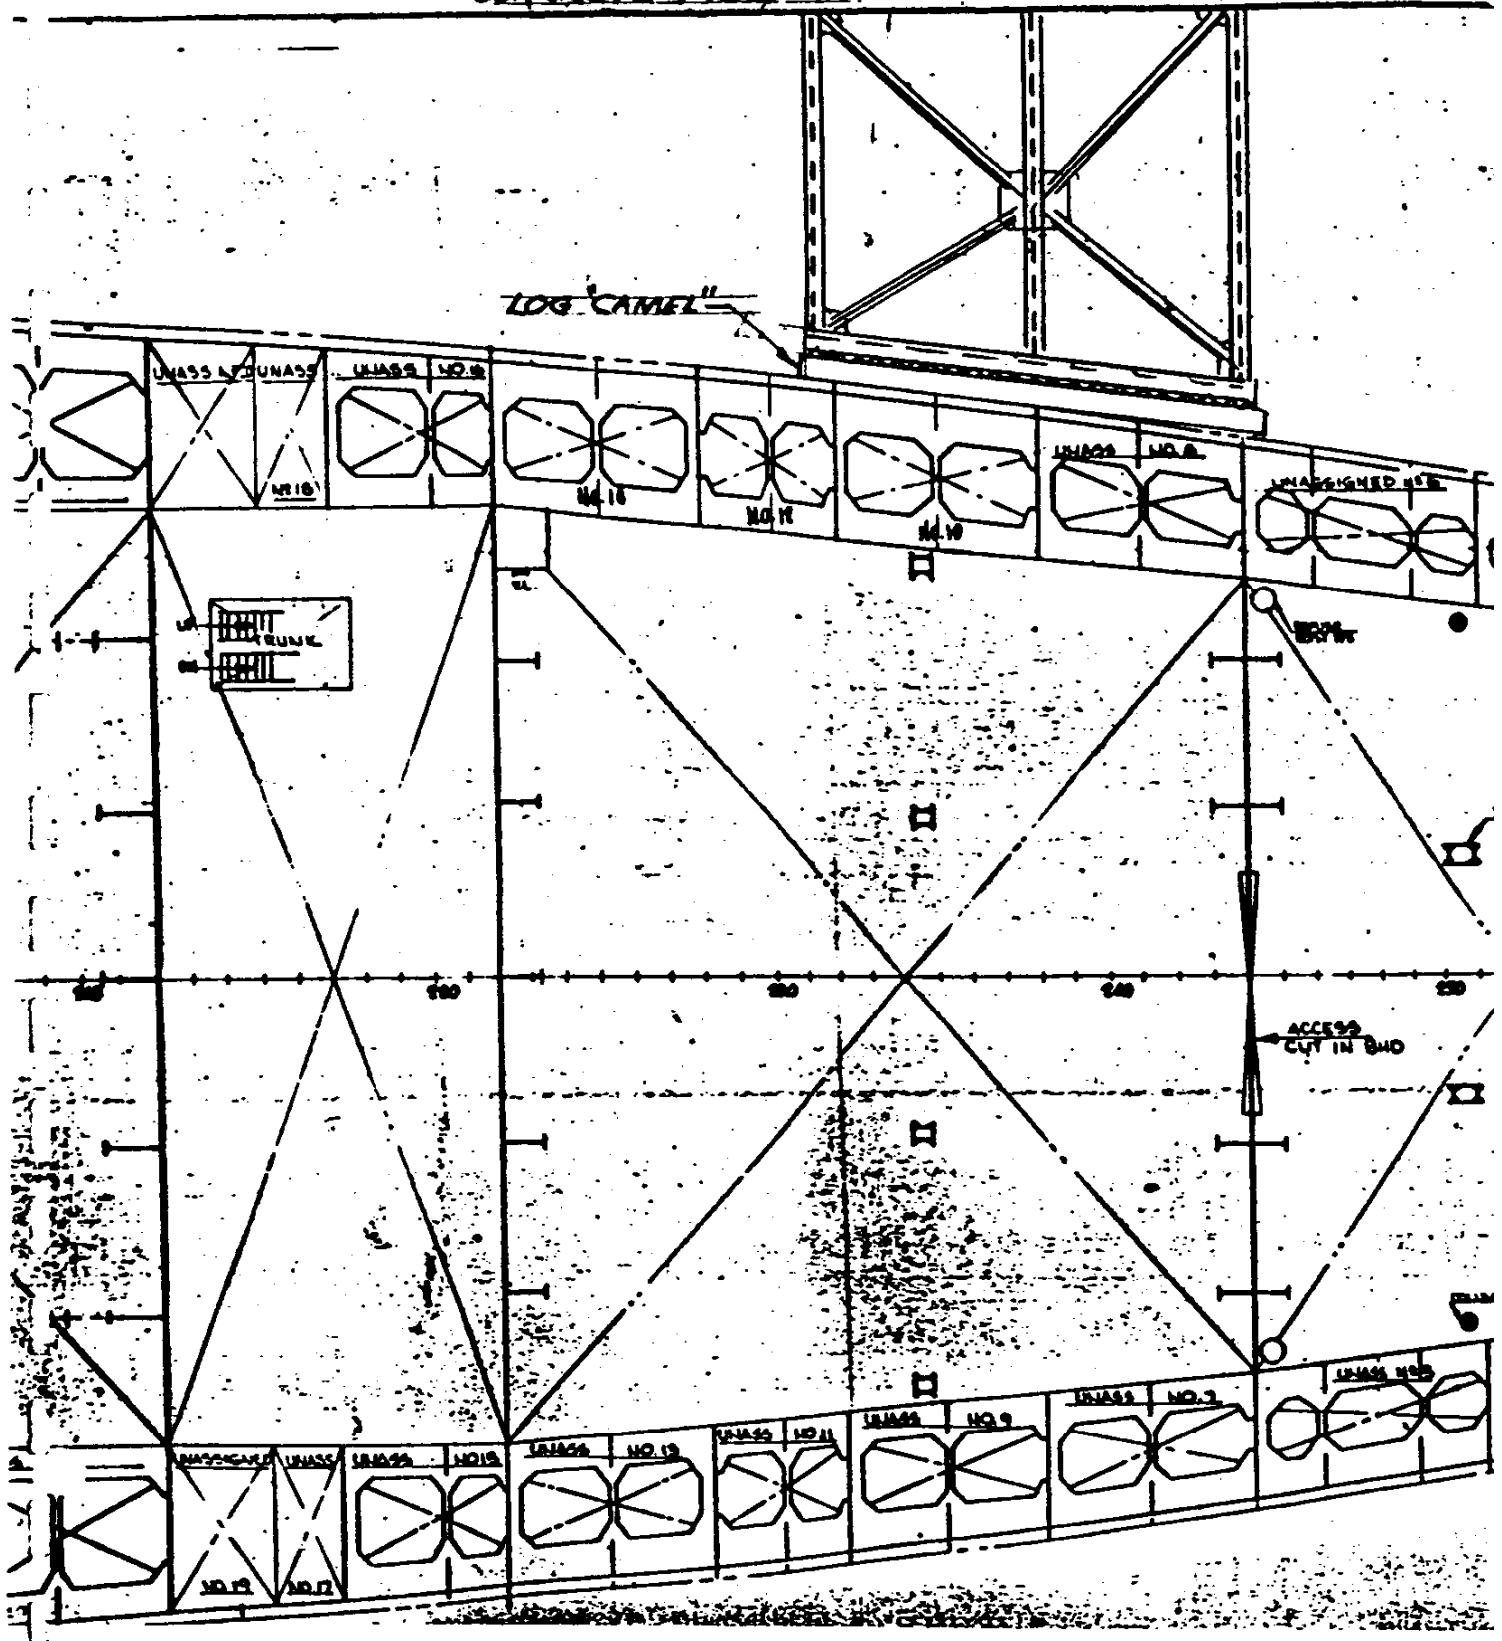
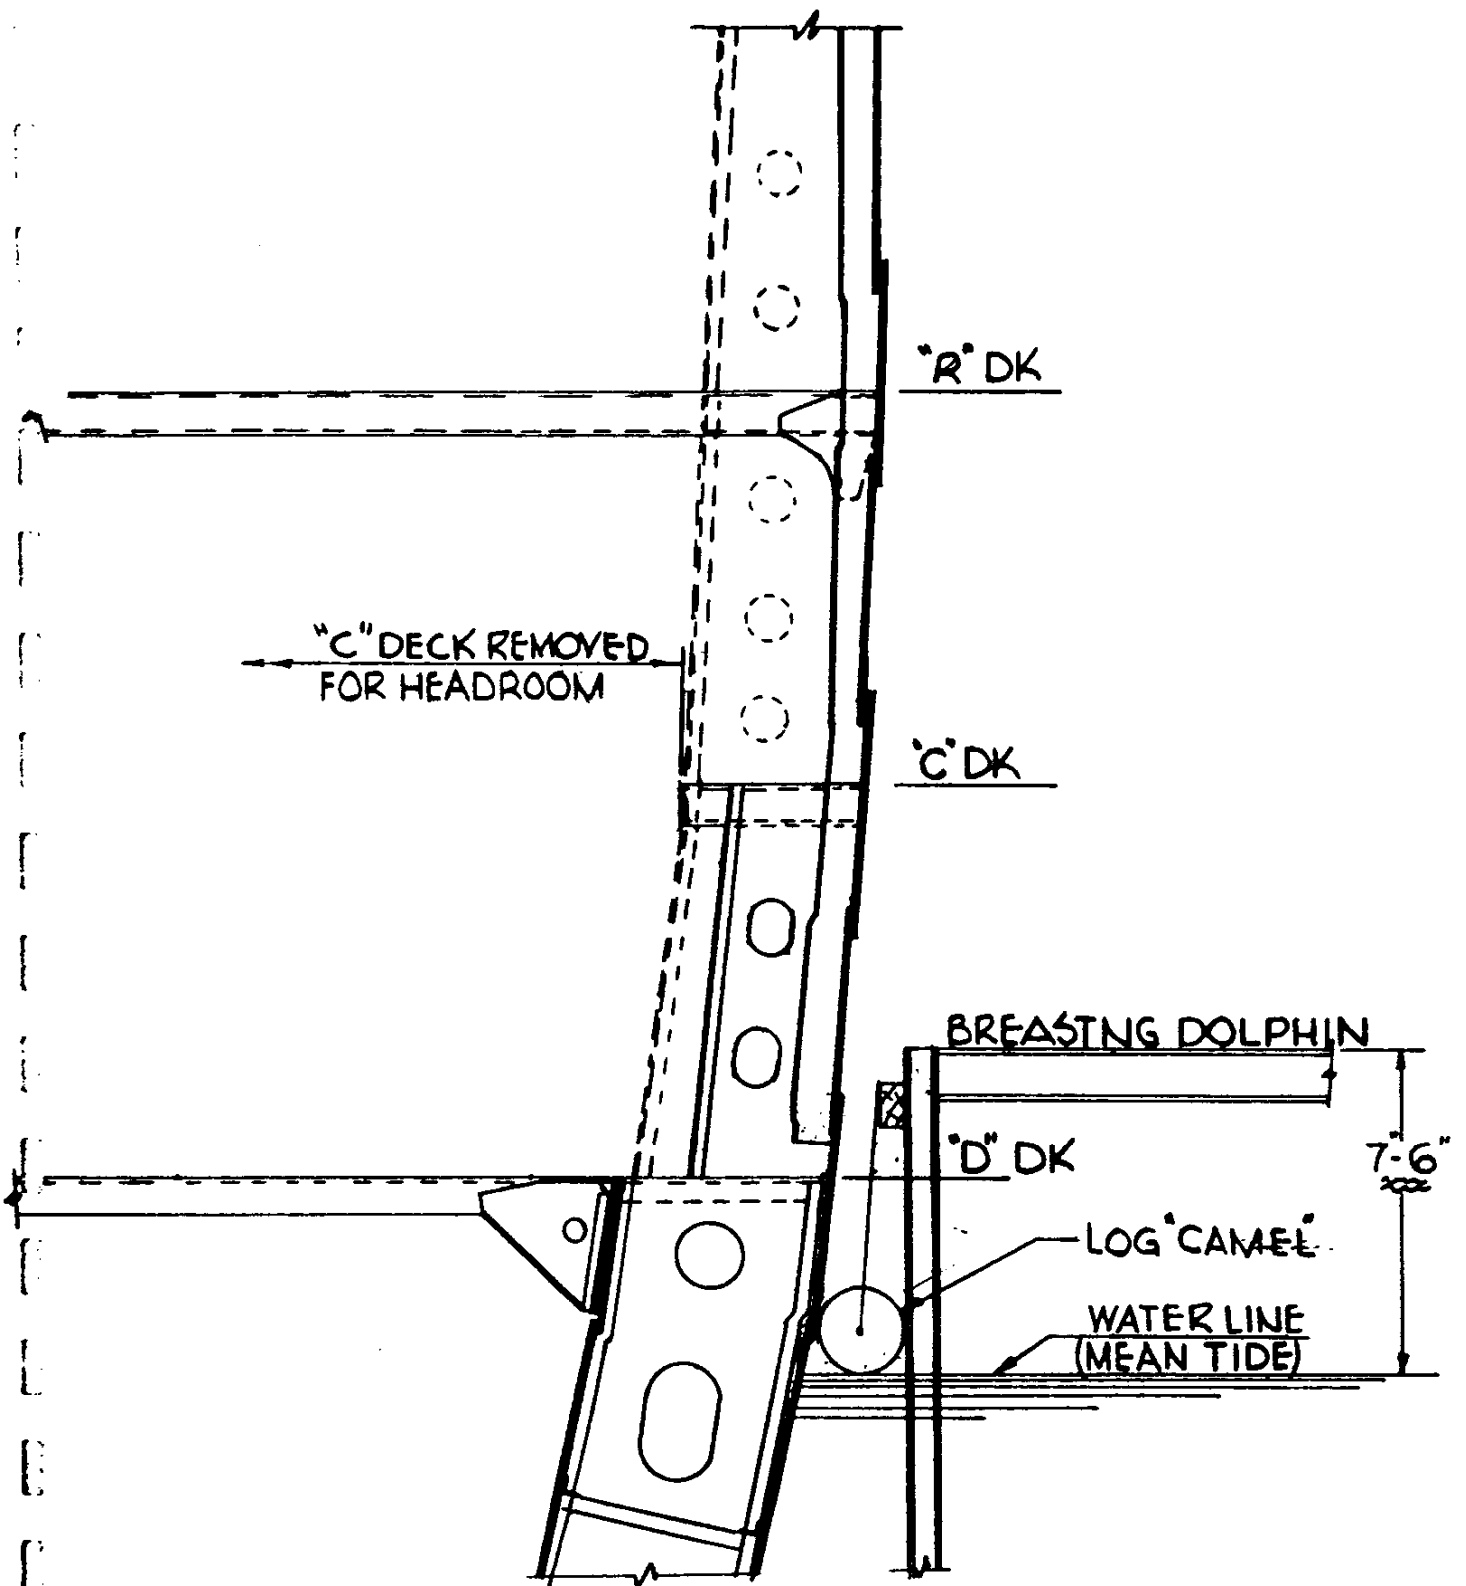
SECTION NEAR FR. 100 AT EXISTING AFT BREASTING DOLPHIN

As a result of the ship's survey, the Queen Mary shows evidence of overstress in the form of deck buckling and distortion in specific areas of the hull structure. The causes of these bucklings were generally due to one or a combination of the following situations:

- o Some of the structural bulkheads were cut out and removed without adequate compensation for strength due to increased loads on upper decks.
- o Due to the age of the vessel, some structures are deteriorated and corroded. No structural reinforcement was made to compensate for loss of strength.
- o The shore fendering system was not properly used for proper distribution of horizontal loads.

It is recommended that if the Queen Mary should be moved or relocated, provisions should be made to install rubber fenders on both aft and forward steel fender structures as outlined in the following RIC Sketch.

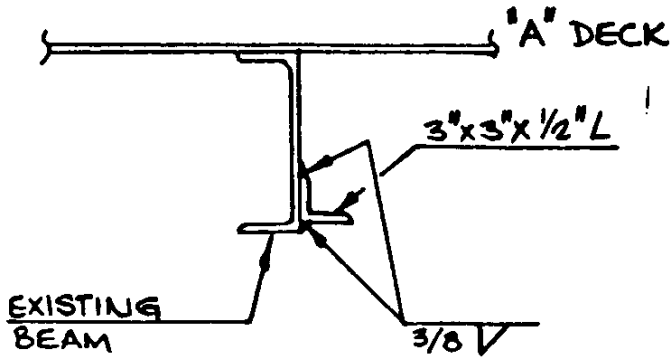
DETAIL 1
BEAM REINFORCEMENT
NO SCALE

The main structural members of the pool side plate also lose strength when the plates deteriorate. The effective width of the plate for main structural members is usually taken as 50 times the thickness of the plating. The existing transverse webs are composed of 6"x3"x0.40" bulb angle. The properties of this bulb angle is not available, therefore, 6"x16.3# channel was used to calculate the strength.
