**QUEEN MARY**

**ANALYSIS OF THE PHYSICAL CONDITION**

VOLUME III  
COST/ENGINEERING

**JULY 1992**

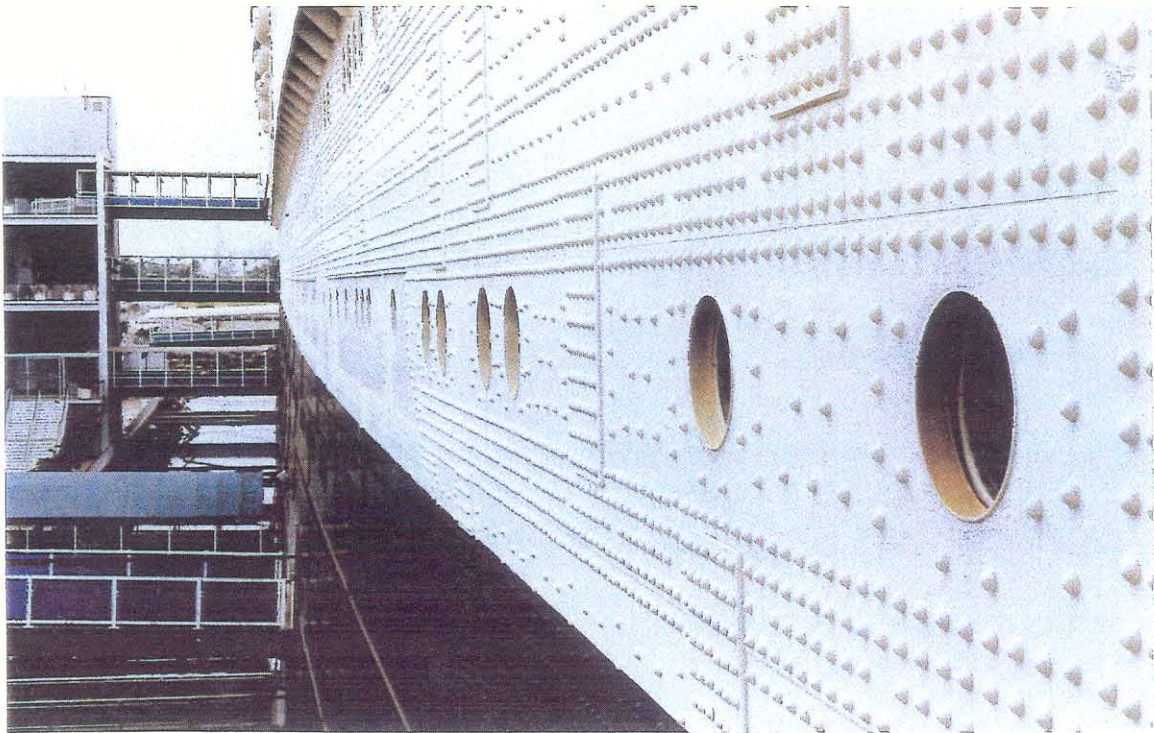
The hull structure of the vessel was constructed using ten million steel rivets to fasten the steel plates to the scantlings. These rivets were 1-1/8 inch in diameter and varying from 2 to 6 inches in length. The hull structure in terms of strength, far exceeds current construction methods, and is considered one of the strongest commercial passenger liners ever built.

**HULL PLATING AND RIVETING PORT SIDE**

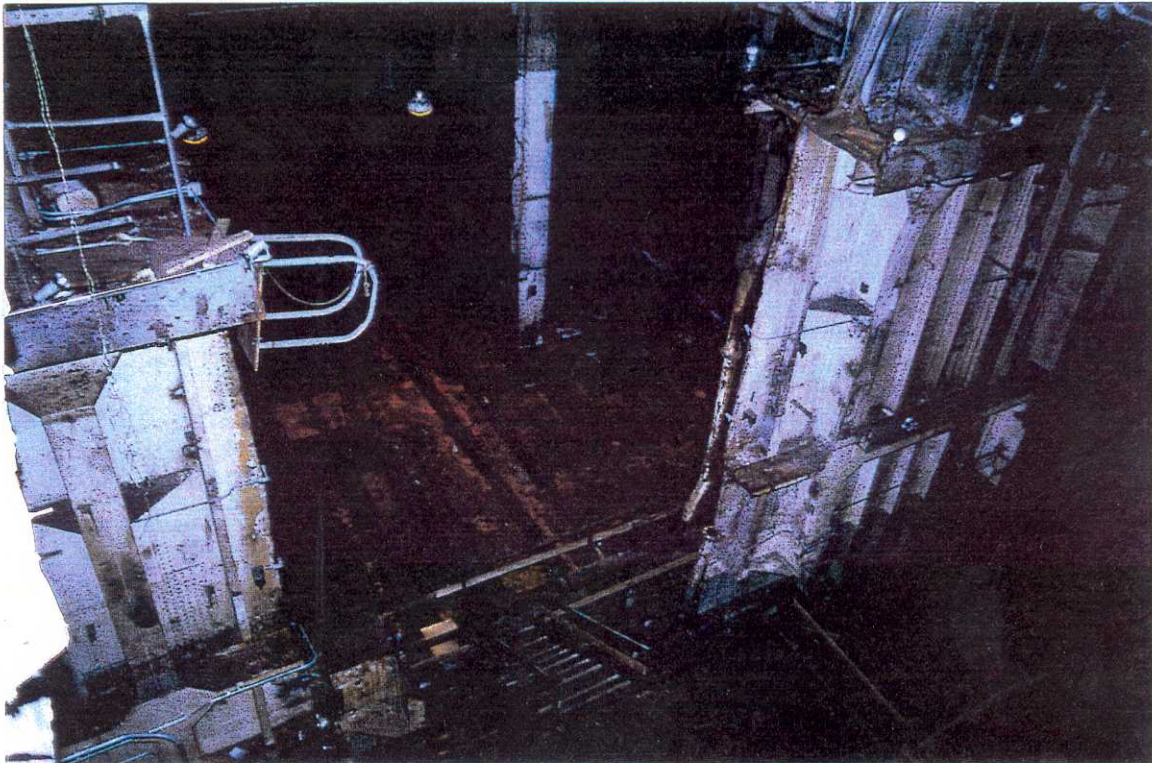
Of the seventeen (17) watertight structural bulkheads in the lower portion of the ship, only two (2) were not modified as a consequence of the conversion modifications. Of the fifteen (15) that were modified, bulkheads 51, 112, 136, 168, 222 and 260 should be repaired/replaced to insure watertight integrity.

**BULKHEAD 190  
TYPICAL CONVERSION MODIFICATION  
TO WATERTIGHT BULKHEAD**

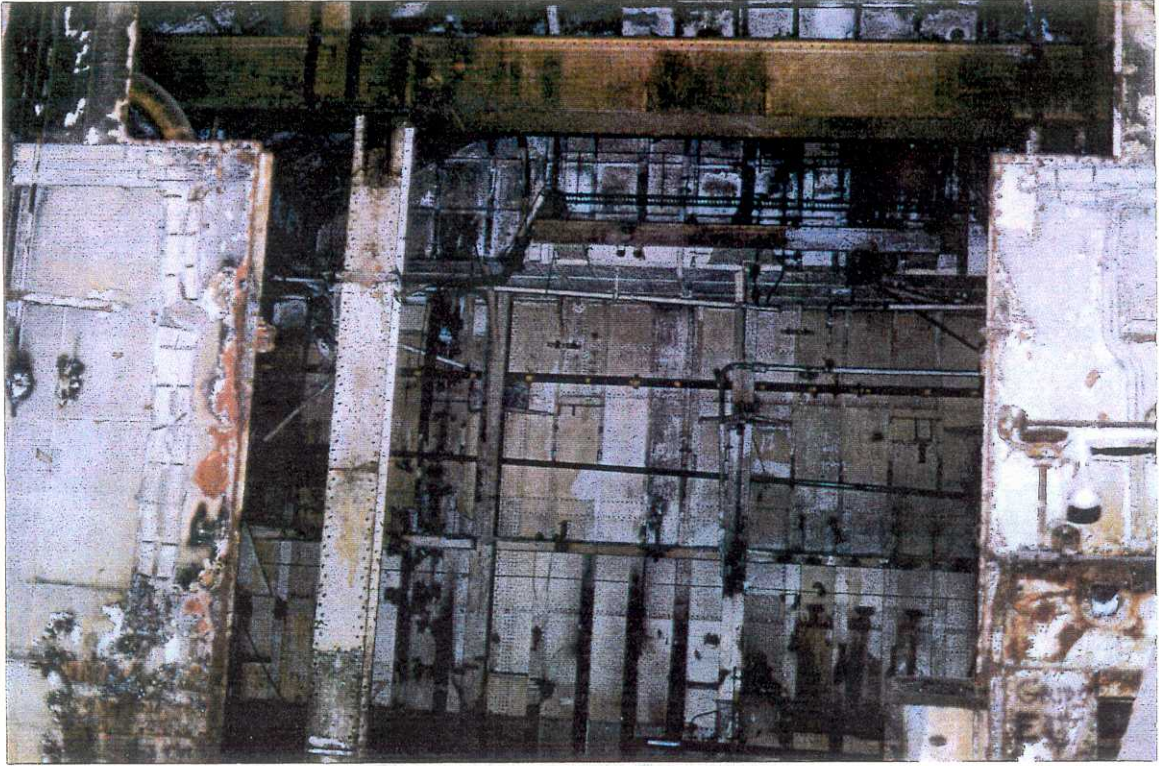
**REMOVED SECTION  
WATERTIGHT BULKHEAD 244  
LOOKING AFT TO BOILER ROOM No. 2**

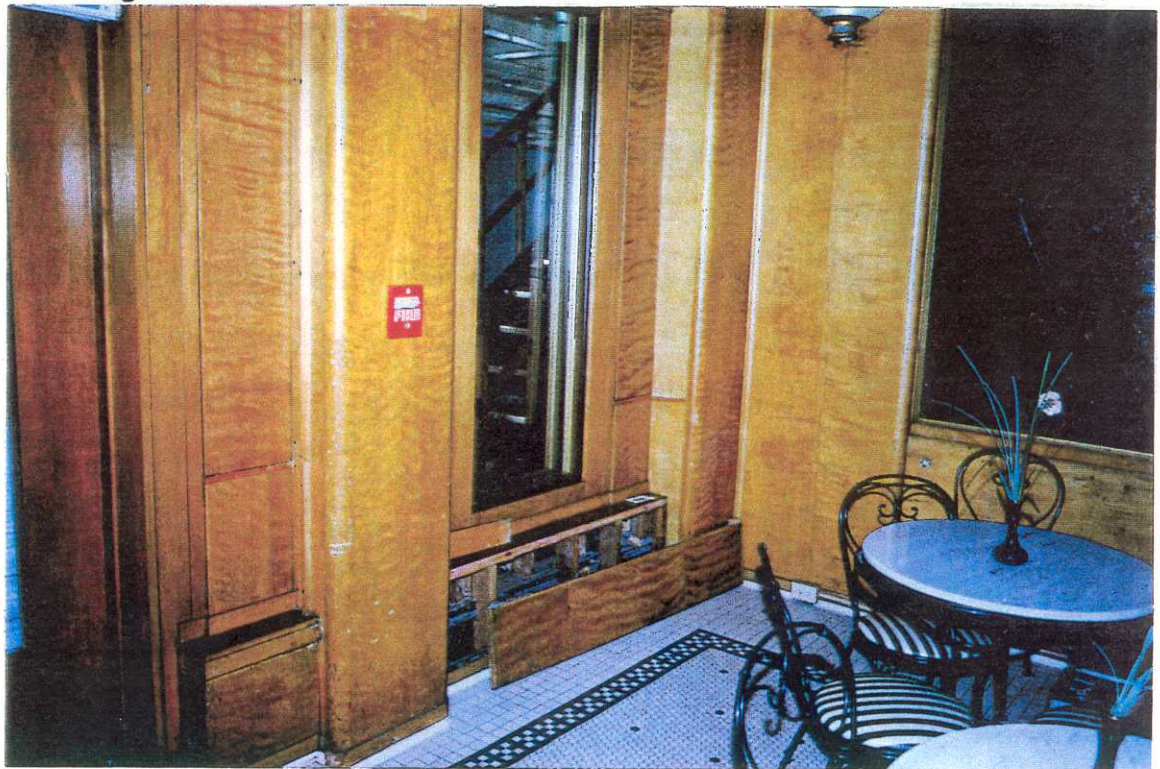
In the construction of the Queen Mary in 1936, the Turner Asbestos Cement Company developed a new fireproof panel called "Turnall Composite Board". This panel consists of a plywood layer, a middle layer of asbestos sheet, and a back layer of plywood. A decorative wood panel was applied over the Turnall Board. All the paneling in staterooms, hallways, lounges, restaurants, etc. contain asbestos containing material.

TYPICAL PANELING SECTION  
PROMENADE DECK, PORT SIDE

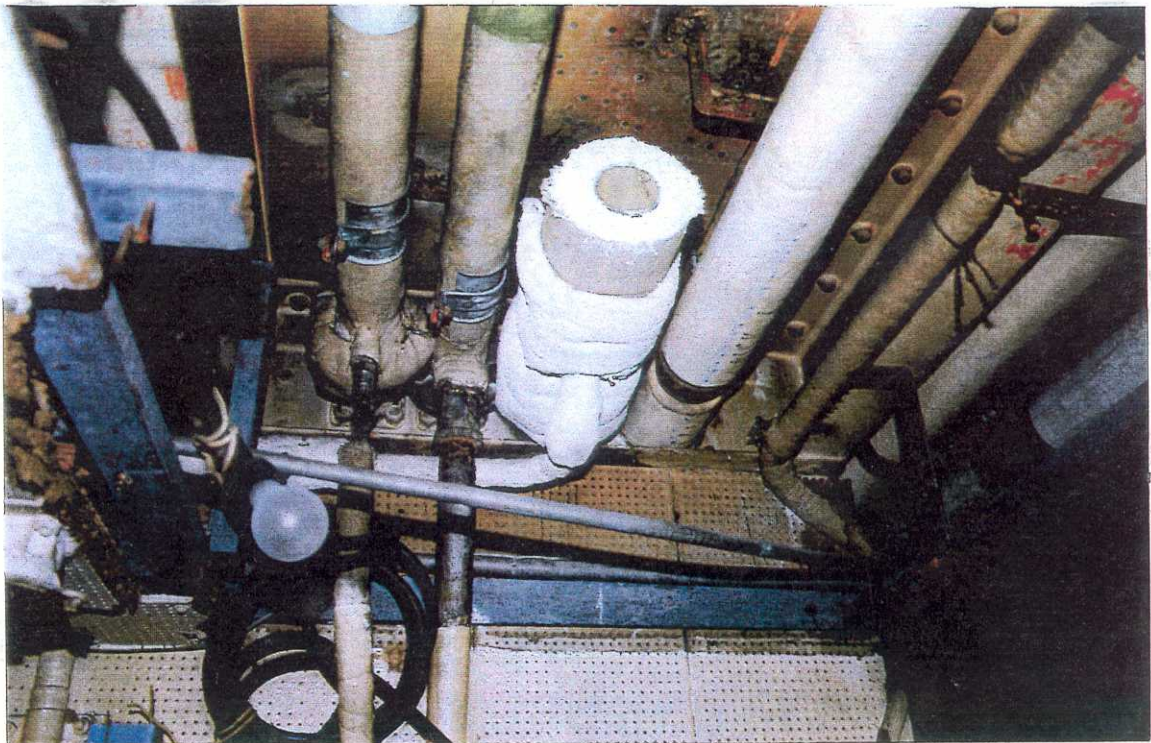
Substantial amounts of asbestos containing material will be required to be removed from the structure both in the overhead panels as well as from the bilge areas, for continued operation of the Queen Mary and for any modification to the structure complex.

**TYPICAL PIPE LAGGING  
"C" DECK WORKSHOP, PORT SIDE**

As a result of needed repairs performed on a continual basis to specific areas of the structure and systems, ACM will be required to be removed in those areas.

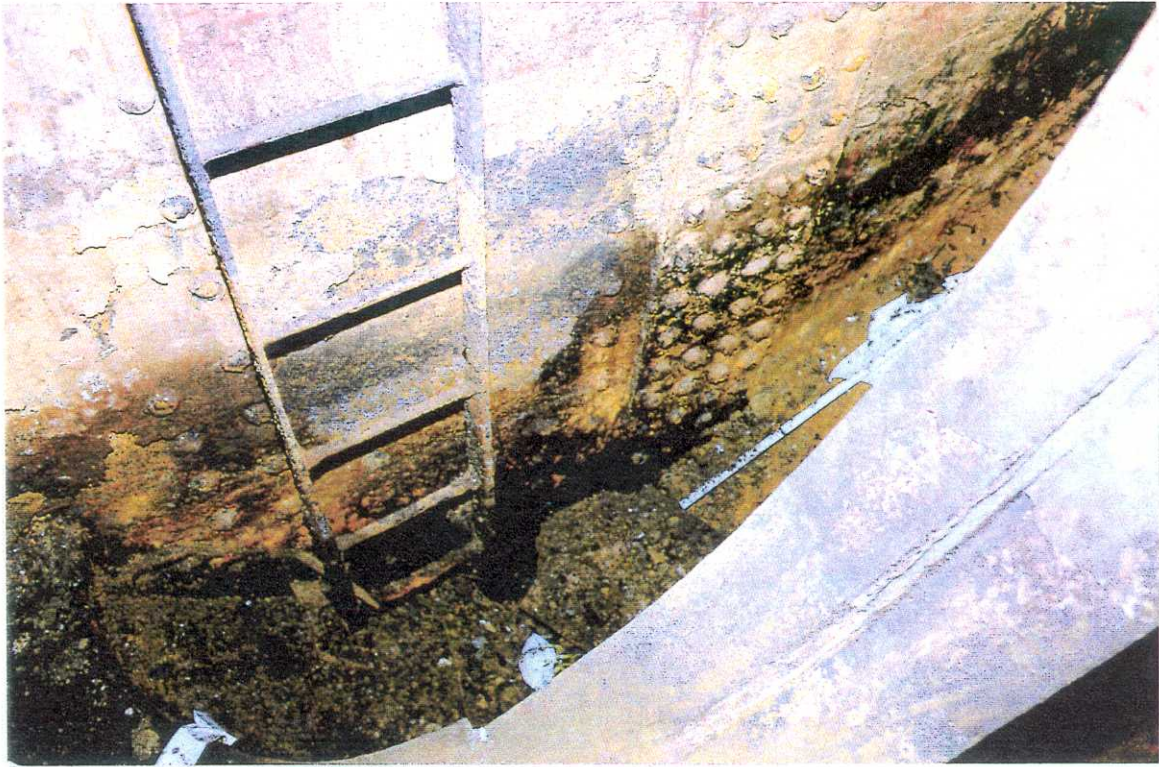
**BILGE AREA, PORT SIDE, AFT**

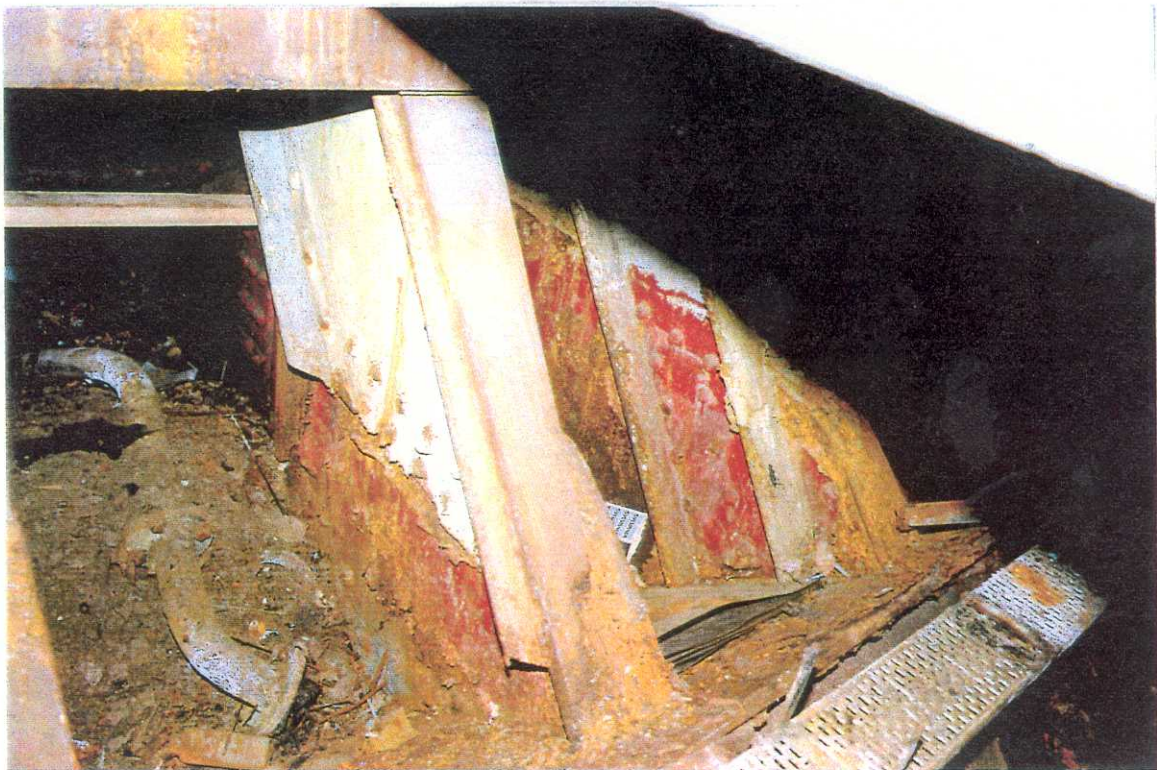
**SHAFT BILGE AREA, STBD SIDE**

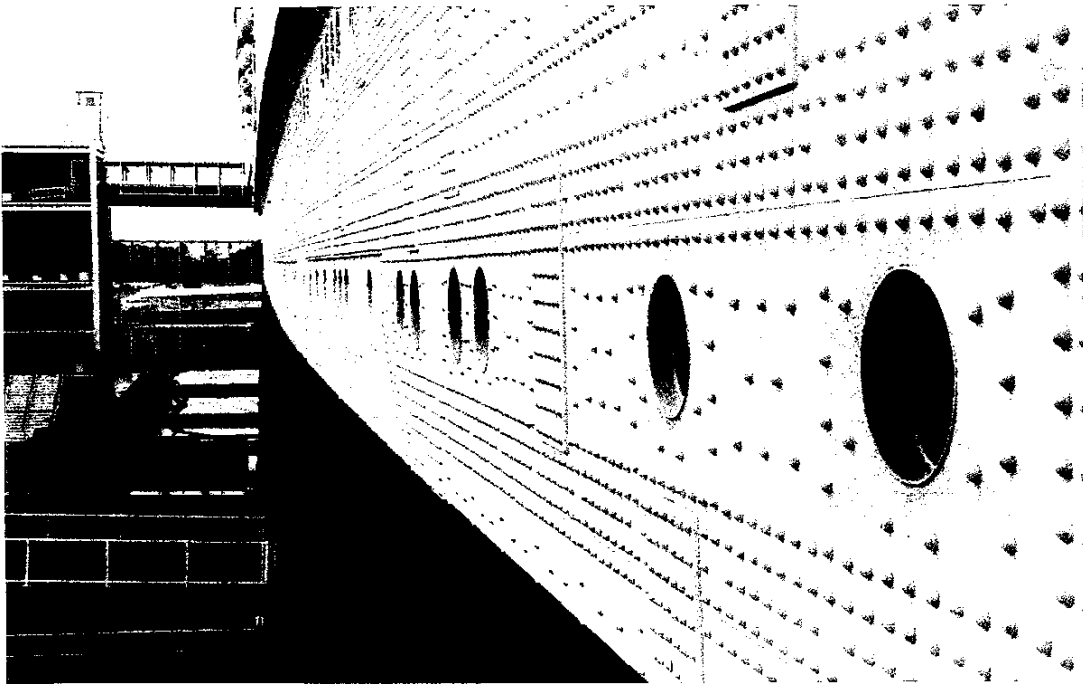
The hull structure of the vessel was constructed using ten million steel rivets to fasten the steel plates to the scantlings. These rivets were 1-1/8 inch in diameter and varying from 2 to 6 inches in length. The hull structure in terms of strength, far exceeds current construction methods, and is considered one of the strongest commercial passenger liners ever built.

**HULL PLATING AND RIVETING PORT SIDE**

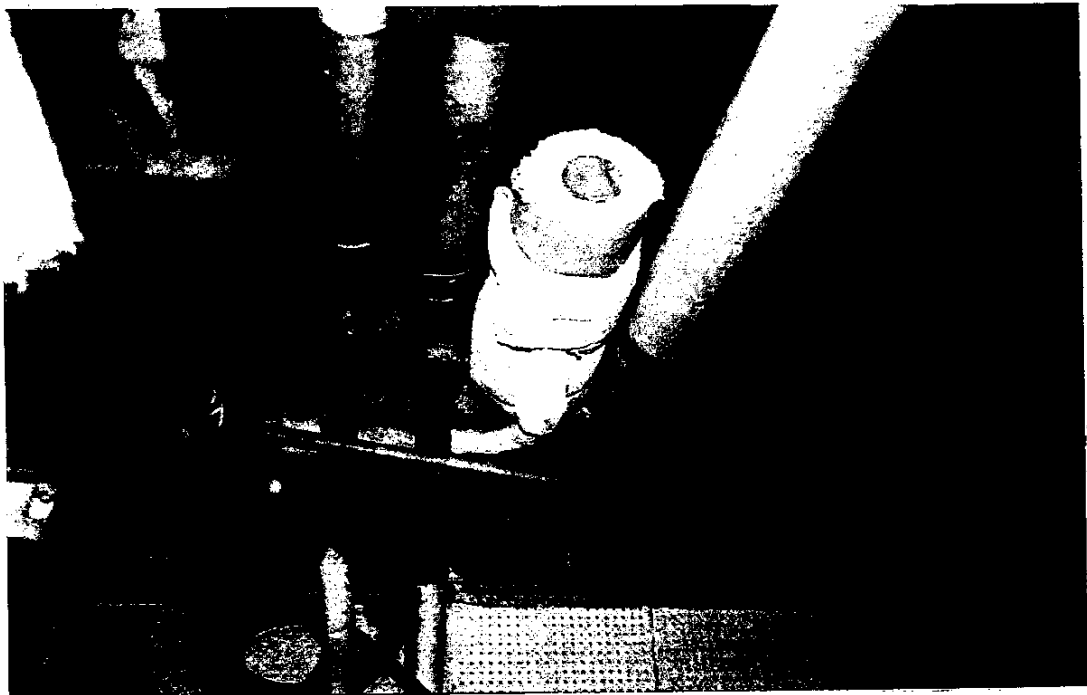
**TYPICAL PIPE LAGGING  
"C" DECK WORKSHOP, PORT SIDE  
VI - 12**

As a result of needed repairs performed on a continual basis to specific areas of the structure and systems, ACM will be required to be removed in those areas.

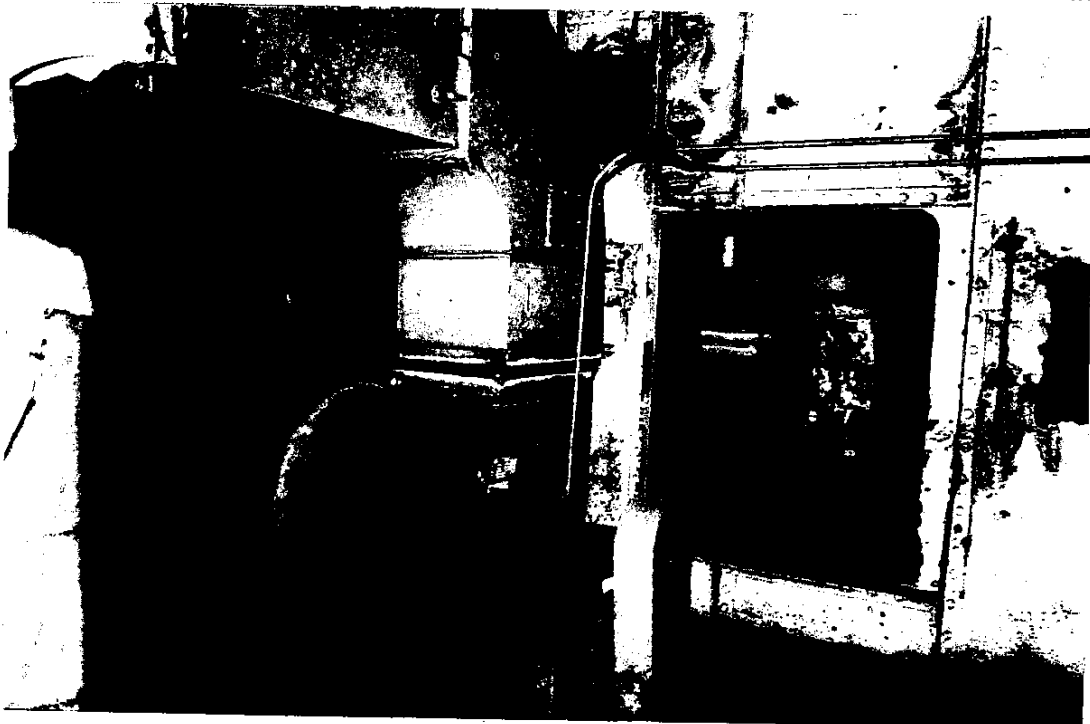
- a. Intake screens are very dirty and in some cases 60% or more clogged with dirt and/or paint which severely restricts the air flow and efficiency.
- b. Systems that have heating and/or cooling coils have clogged or missing air filters.
- c. Flexible rubberized canvas duct connectors have holes, and in some cases are torn or in a deteriorated condition.
- d. Noisy bearings and out of balance fan wheels cause excessive vibration.

**SUPPLY FAN AT FRAME 178**

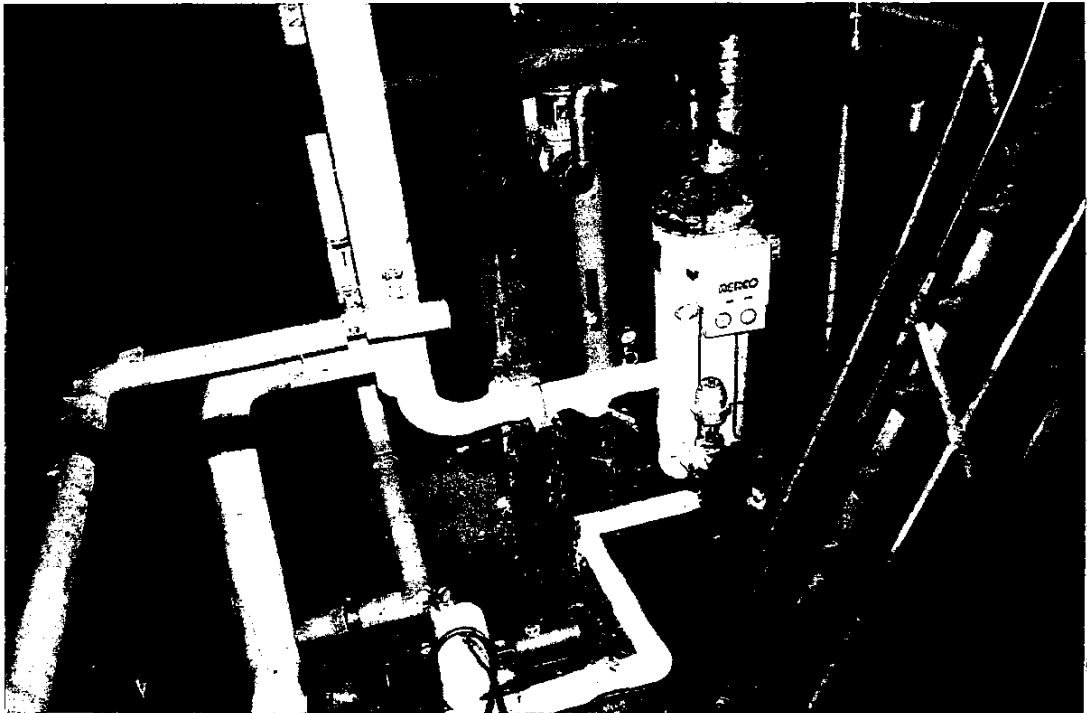
**SEWAGE SYSTEM  
"F" DECK, PORT SIDE**

Pumps appear to be in good condition, and this is borne out by maintenance personnel. Due to the length of time in use, pumps should be overhauled completely to avoid future problems.

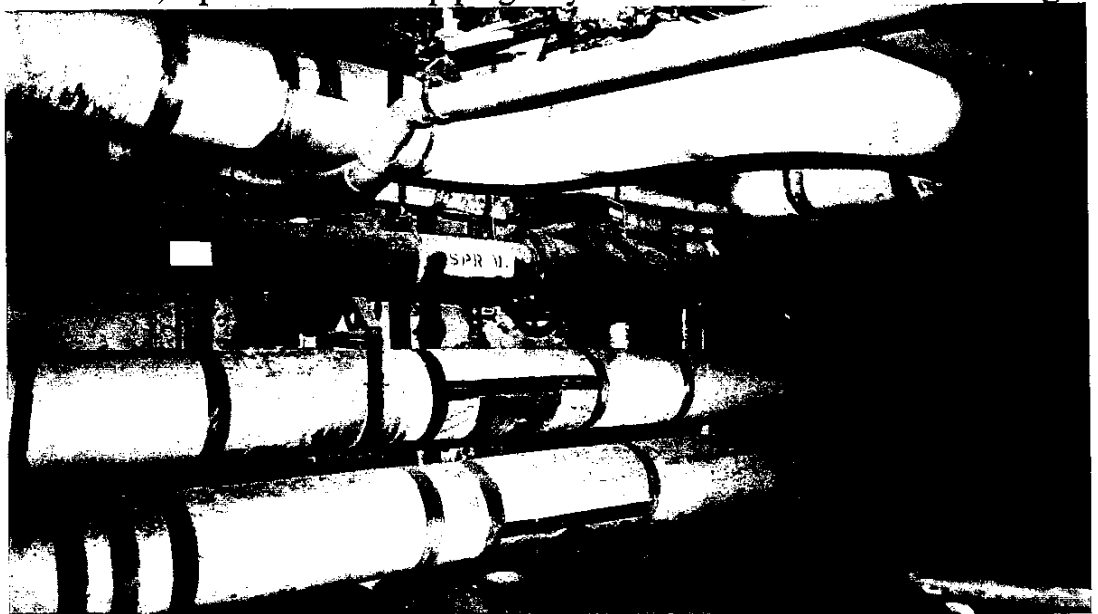
**FIREMAIN AND SPRINKLING MAIN  
AT POINT OF HULL PENETRATION**

There is presently at least 40 feet of firemain which has developed leaks. This is an indication that further problems will arise in the future, due to the deterioration of the piping.

The Firemain and Sprinkler Systems are served from the shore by separate lines. Both systems after many years of use, should be flushed and hydrostatically pressure tested in their entirety plus perform any other test required by the Long Beach Fire Department. Results of these tests will help determine the condition of the systems and the extent of repairs to be made. Should these tests indicate extensive rework, replacement of all piping may be more cost effective for the long term.

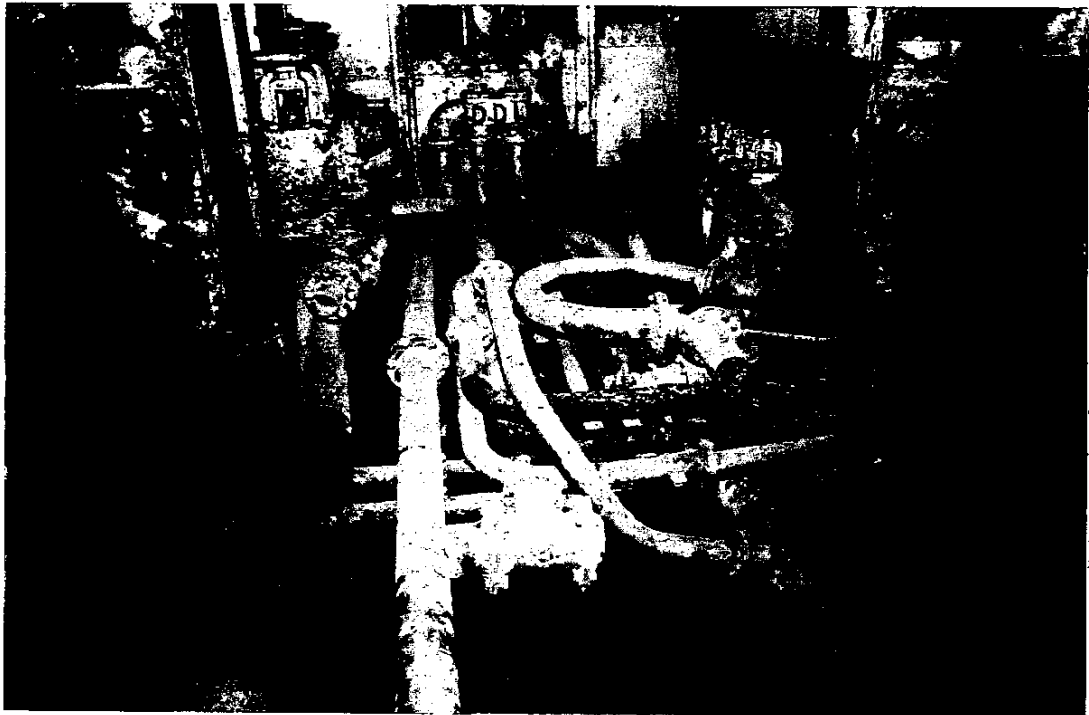
Piping installed during the conversion is PVC mixed with steel, and in fair to good condition. All bilge wells are clean and have water to cover the suction strainer. Bilge piping forward of frame 260 is badly corroded, with some sections completely rusted out, making the system inoperative. Some piping has been replaced at some of the bilge wells. Watertight bulkheads which could ordinarily isolate various areas of the bilges are non-existent, subjecting the ship to total flooding in case of a catastrophic disaster.

**PART OF BILGE PIPING SYSTEM**

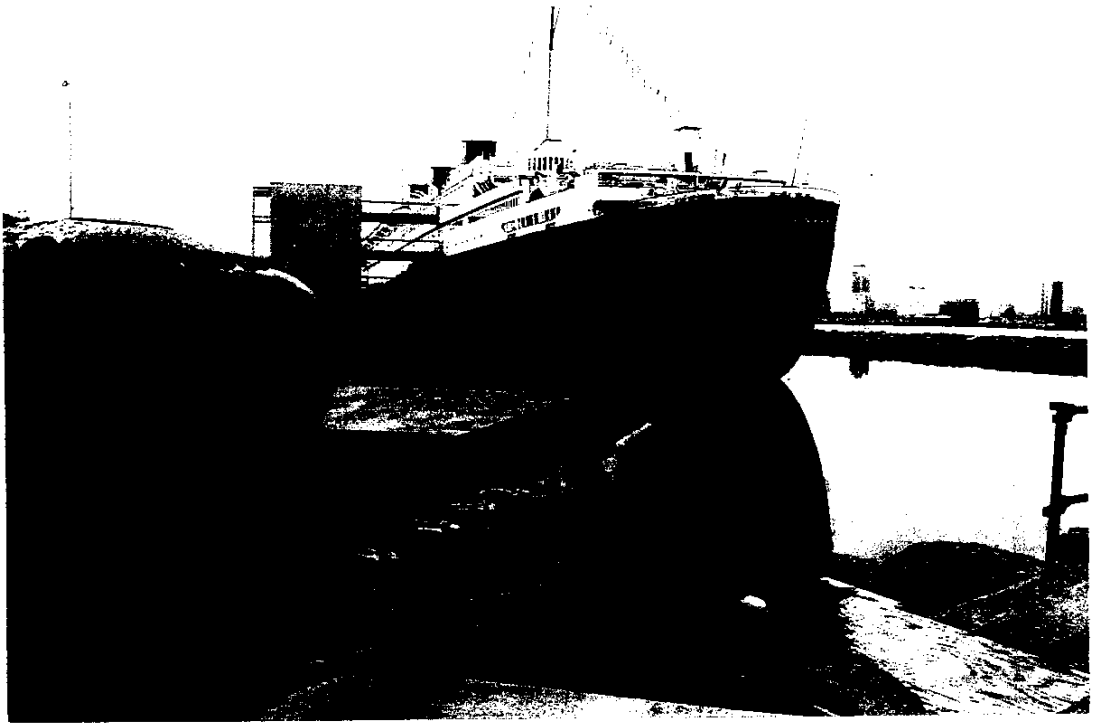
The inspection of mooring lines indicate a majority of the wire cables require replacement due to corrosion from the saltwater atmosphere. Investigation of all pad eyes and fittings for repairs and replacement, to be performed.

**MOORING LINES/CABLES**
